Technical Service Bulletin

01 Engine does not start, rough running, excess moisture found in intake piping

01 13 04 2032958/1 June 6, 2013.

Model(s)	Year	VIN Range	Vehicle-Specific Equipment
A3 TDI	2010-2013	All	Not Applicable

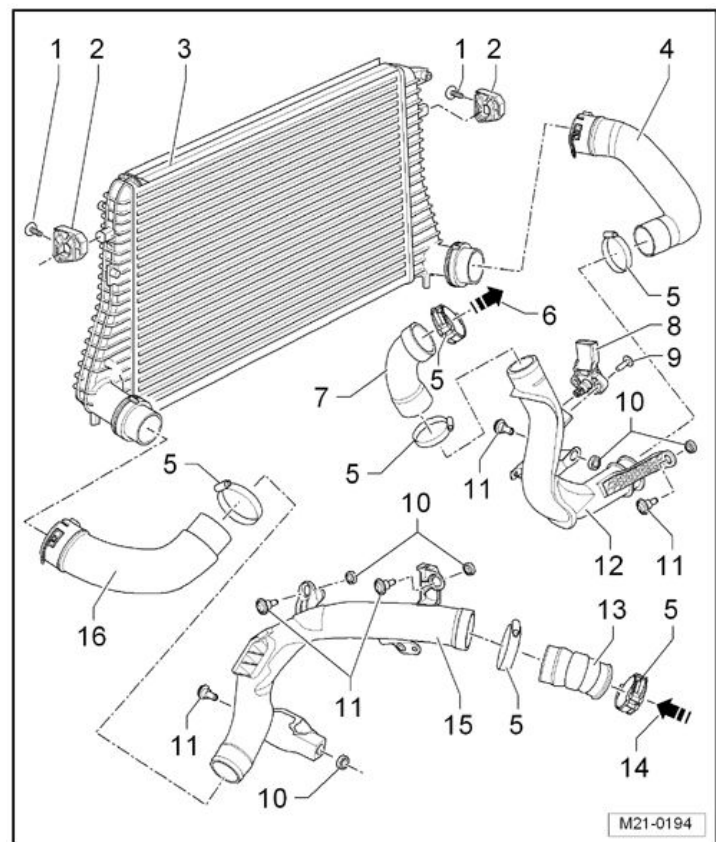
Figure 1: Charge air cooler and intake hose layout

Moisture from the intake air condenses and collects in the charge air cooler. At cold temperatures, this moisture can freeze, causing blockage of the intake air system.

1. Lock carrier in service position. See *Repair Manual* >> *Group 50* in ElsaWeb.
2. Remove radiator and radiator fan assembly.
3. Separate A/C condenser from charge air cooler.
4. Remove the original charge air cooler (Figure 1, number 3) from the vehicle.

5. Remove the lower charge pressure hoses (Figure 1, numbers 4 and 16) and clean off any moisture or sludge. See *Repair Manual Group 21* >> *Turbocharger/G-Charger* >> *Description and Operation* >> *Component Overview* in ElsaWeb.
6. Remove cold side charge air pipe (Figure 1, number 12) and pressure hose to throttle valve (Figure 1, number 7).
7. Separate the A/C condenser from the charge air cooler.
8. Separate the charge air pressure sensor –G31– from cold side charge air pipe.

17. Install the revised charge air cooler (Figure 1, number 3) with regulating flap and connect the regulating flap vacuum hose.
18. Re-assemble all charge air pipe connections.
19. Connect A/C condenser to charge air cooler using fasteners from kit, and install radiator with fan assembly.
20. Reassemble front carrier.
21. Re-aim headlights.

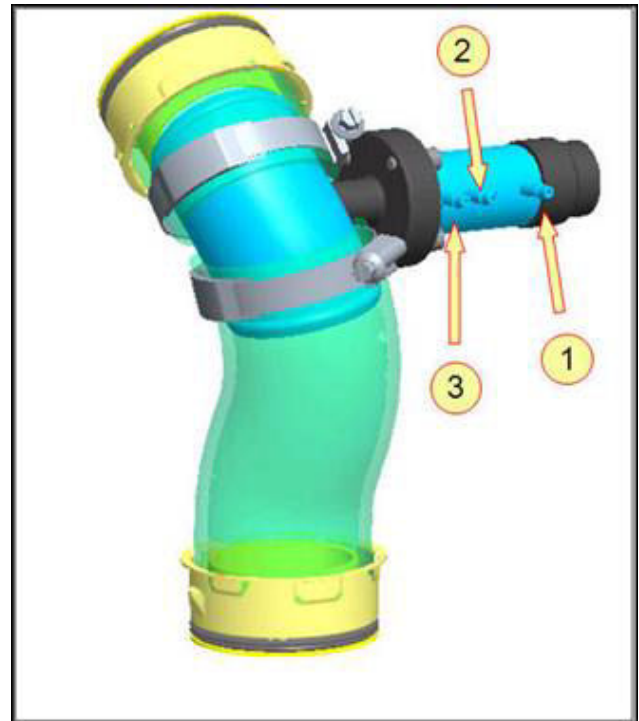
Figure 2: Vacuum hose routing on temperature switch, showing ventilation hose to air cleaner (1), hose to vacuum source (2), and hose to charge air cooler regulator flap (3).

11. Install the cold side charge air pipe (Figure 1, number 12) and connect the charge air pressure sensor -G31- electrical connector.
12. Note the vacuum hose routing on the temperature switch (Figure 2).

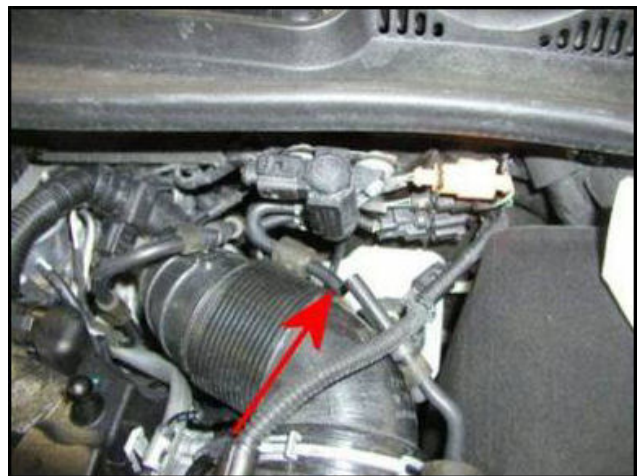
Figure 5: The red arrow indicates where to cut ventilation hose.

14. Cut ventilation hose to air cleaner (Figure 5).
