TECHNICAL BULLETIN  
K185NAS1  
16 AUG 2013

Service Action: Stowage Box Lid

**F-TYPE (X152)**

**Model Year:** 2014  
**VIN:** K00317-K03880

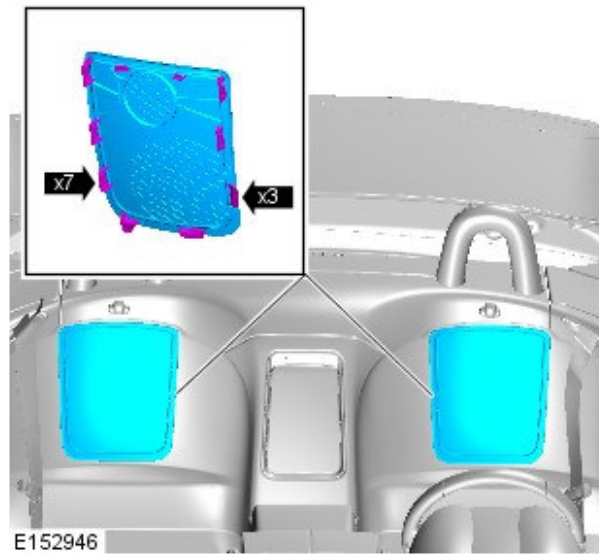
**NOTE: Speaker grille shown; carpet cover similar.**

Position the seats to gain access to the speaker grille/carpet covers.

- Release clips and remove the speaker grille/carpet covers.

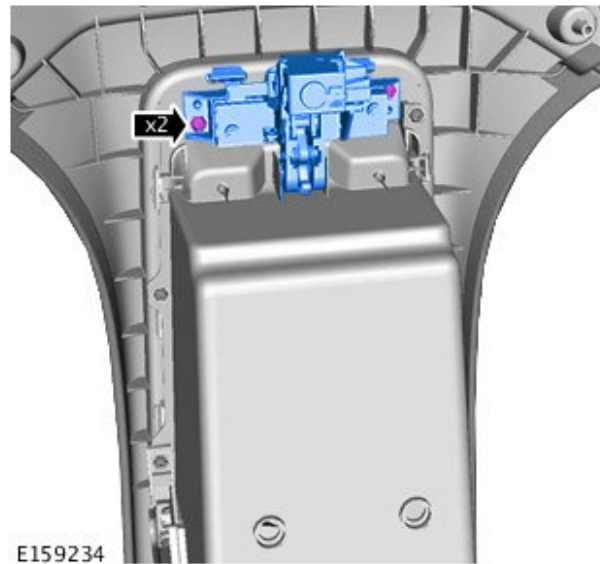
**Situation:** An issue has been identified on a limited number of 2014 model year F-TYPE vehicles, fitted with the rear bulkhead lockable stowage box, where the lockable stowage box lid may unlatch and open when locking the vehicle.

**8.** Undo the fixing; remove and discard the latch:

- Install the new latch
- Tighten fixings to 1.0 Nm +/- 0.2 Nm.
