TECHNICAL BULLETIN
JTB00323NAS1
16 DEC 2013

Rocker Panel Moulding Paint Delaminating

F-TYPE (X152)

Model Year: 2014

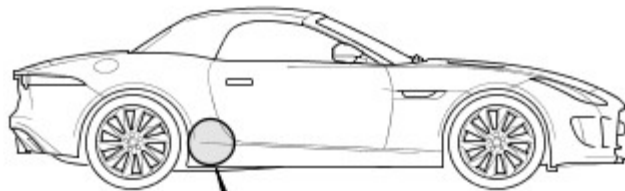
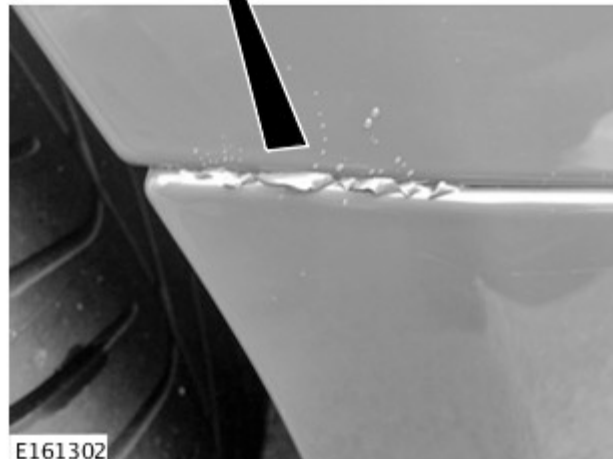
1.

Situation: Paint delamination / rub marks on the rocker panel moulding to rear quarter panel area in front of the rear wheel may be evident.

Cause: This may be caused by the location clip on the rocker panel moulding to body bracket not fully latching home.

Area of concern.

2. Remove the affected rocker panel moulding (see TOPIX Workshop Manual, section 501-08).
3. Repair and paint the damaged area on the rocker sill moulding.
4. Remove the three mounting bracket bolts.
