Technical Service Bulletin

97 Multiple warning lights illuminated; communication error DTCs

97 13 40 2034945/2 November 26, 2013. Supersedes Technical Service Bulletin Group 97 number 13-37 dated August 8, 2013 for reasons listed below.

Model(s)	Year	VIN Range	Vehicle-Specific Equipment
Q7	2010 - 2014	All	Not Applicable

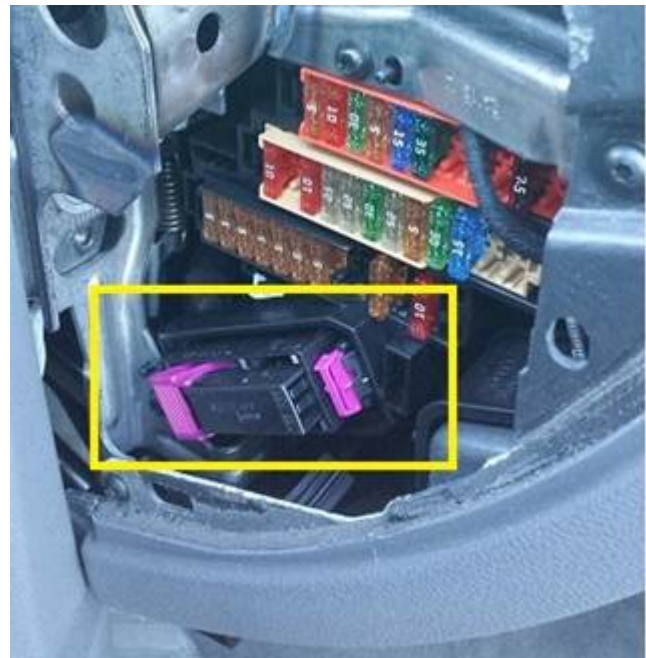
Figure 1. T46a CAN disconnect plug, left dashboard.

There is sporadic data disruption on the CAN bus wiring behind the dashboard, between the left (T46a) and right (T46b) 46-pin CAN disconnect plugs.

1. Upload GFF paperless log showing communication DTCs as described in the complaint.
2. Overlay new CAN twisted pair wiring behind the dashboard, between the two 46-pin CAN disconnect plugs (T46a/1H <-> T46b/1H and T46a/1L <-> T46b/1L) (Figure 1 and Figure 2).

3. Replace the terminals with the VAS1978B repair kit.
