Technical Service Bulletin

00 - Engine shuts off and/or EPB activates when driver door is opened

00 13 46 2031850/3 March 13, 2013. Supersedes Technical Service Bulletin Group 00 number 13-44 dated January 17, 2013 for reasons listed below.

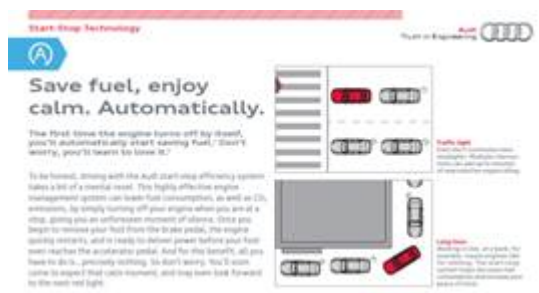
Figure 1. Old Start-Stop glovebox insert.

4. If available, replace the old Start-Stop glovebox insert (Figure 1), with the new glovebox insert **BR-12-631-US** (Figure 2). Additional inserts may be ordered from the Brand Store.

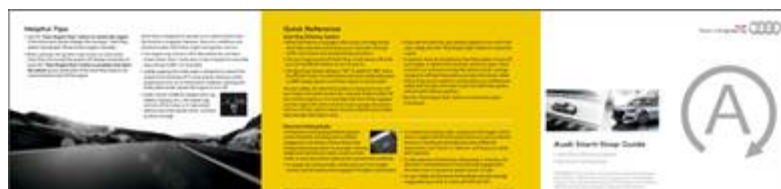
Figure 2. New Start-Stop glovebox insert.
