Technical Service Bulletin

01 MIL on (DTCs P2015, P2020)

01 13 50 2030192/2 December 20, 2013. Supersedes Technical Service Bulletin Group 01 number 12-55 dated October 22, 2012 for reasons listed below.

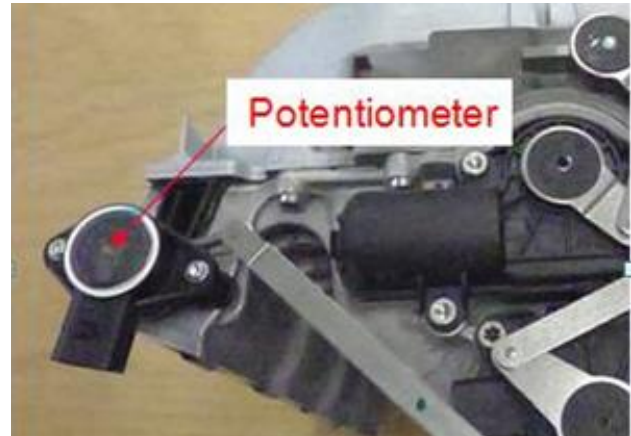
A deformed oil seal behind the potentiometer (Figure 1) causes a linkage of the intake manifold flap adjustment to stick, which sets the DTCs.

Figure 1. Potentiometer.

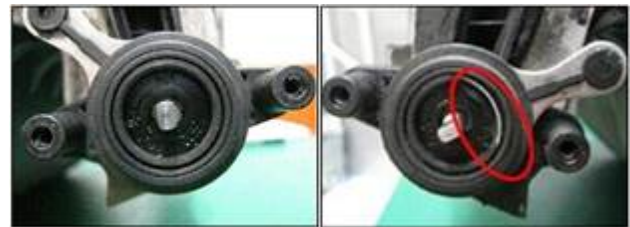
When the potentiometer is removed, the oil seal can be seen (Figure 2).

Figure 2. After the potentiometer is removed, the oil seal can be seen. The image on the left shows a correct oil seal and the image on the right shows a deformed oil seal.

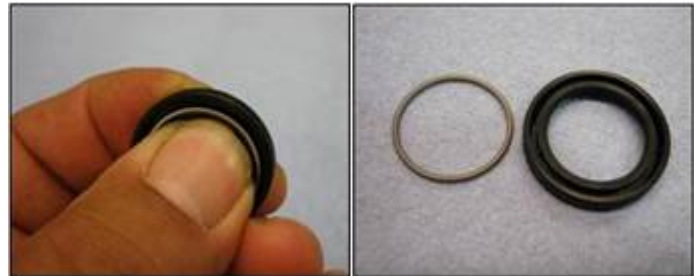
Figure 3. The image on the left shows the correct way to remove the spring. The image on the right shows the spring after it has been removed.

2. To avoid sticking linkage in the future, remove the seal spring before installation (Figure 3). Use your finger to remove the spring. Screwdrivers or other tools may damage the sealing lip.

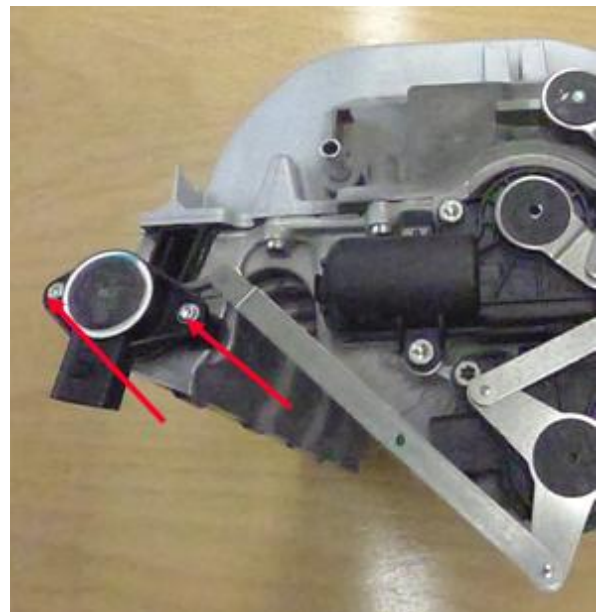
Figure 4. Two M4x14 bolts to be removed.

3. Remove the potentiometer by removing the two M4x14 bolts (Figure 4), then check the potentiometer and its flange for damage.

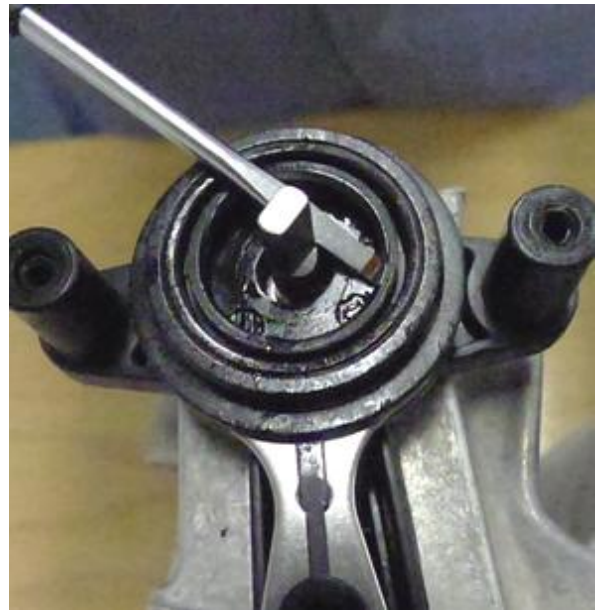
Figure 5. Removing the seal with a screwdriver.

4. Use a screwdriver to gently remove the seal ring by pushing the screwdriver under the seal (Figure 5).

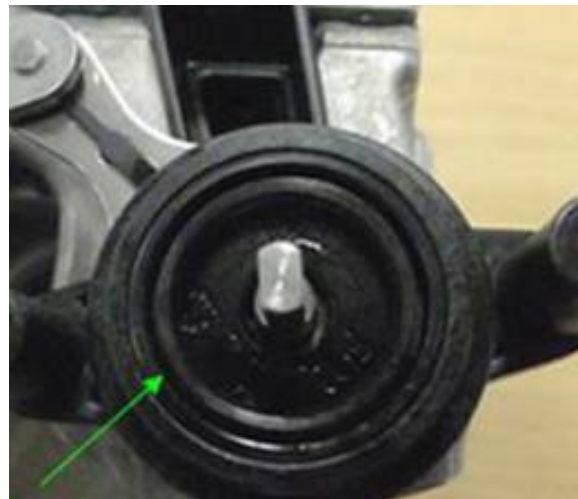
Figure 6. Correctly-inserted seal.

5. Clean the potentiometer seal mounting area, then lightly oil the surface with 10W40 motor oil.
6. Insert the seal. The open side of the seal faces the potentiometer. Use your fingers to press the seal ring into the seal mount firmly. Ensure that the seal is fully inserted (Figure 6).

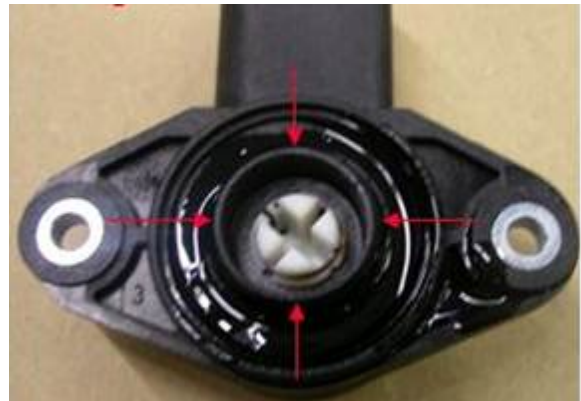
Figure 7. Lightly-oiled sensor.

7. Lightly oil the potentiometer before installation. Additionally, apply oil the contact surfaces of the sensor (Figure 7) and inner ring of the lip seal ring

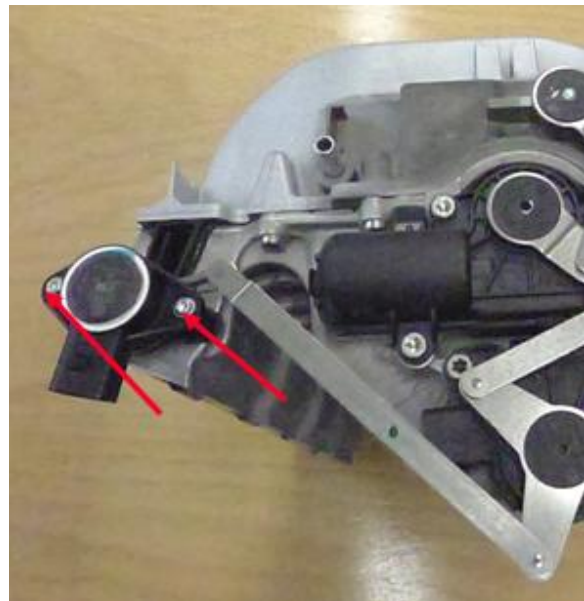
Figure 8. Two bolts to be tightened.

8. Fit the potentiometer then fit the sensor with a light turning movement. Attach it with 2 bolts (M4X14), tightening torque 1.7Nm + 0.2 Nm (Figure 8).
