TECHNICAL BULLETIN

UPS0911-5bNAS5

Update Prior to Sale: Instrument Cluster Telltales (NHTSA #11V-239)

XJ (X351)

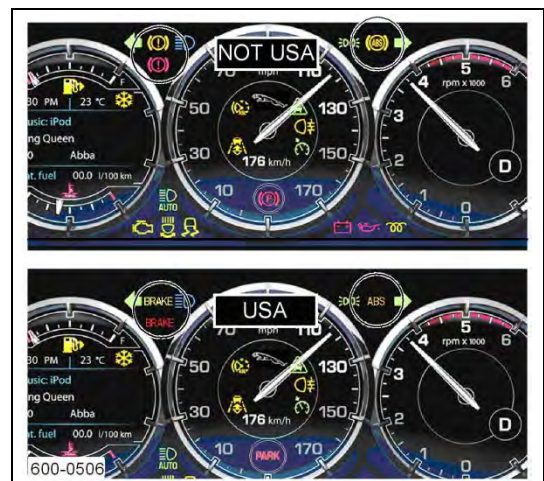
△ NOTE: The brake warning lamp text will normally only be visible for a few seconds during the cluster bulb check.

12. After the update has completed, cycle the ignition 'OFF' then 'ON'; verify that the yellow and red brake warning lamps now appear as text rather than icons.
