SERVICE BULLETIN

APPLICABILITY: 2013MY BRZ

NUMBER: 12-152-13

SUBJECT: Door Mirror Loose / Vibrating

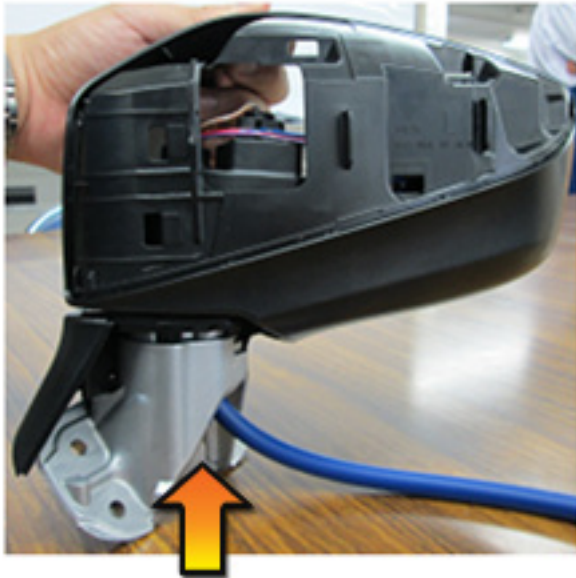
1. Follow the procedure outlined in the applicable Service Manual for removing the mirror assembly. After removing the mirror assembly, remove the 3 Phillips screws which hold the mirror head to the base as circled in the photo below.

NOTE: This service procedure applies only to mirror heads secured to their mounting base with Phillips screws. If you find the new hex-head bolts are already in place, diagnose the cause of the loose mirror head and repair or replace accordingly.

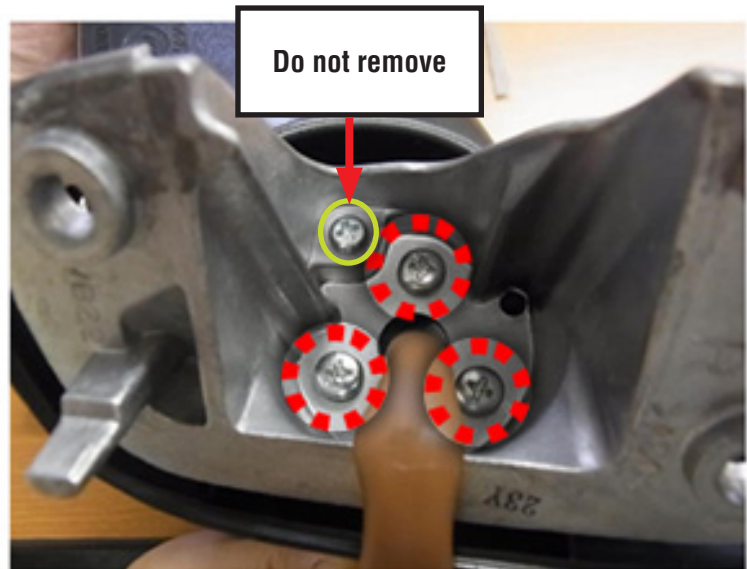
Arrow indicates where to look for the three Phillips screws.

IMPORTANT: Avoid damaging the Phillips drive portion of the screws by using a good No. 2 size Phillips screw driver. They are installed with a thread locking compound and may require some extra force to remove.

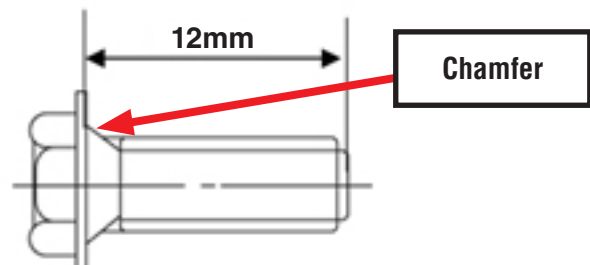
(Original M5 Phillips head screw)

(Replacement bolt)

M5 hexagon head bolt with flange
