## SERVICE BULLETIN

**APPLICABILITY:** 2013 Legacy & Outback Models with 2.5L  
 FB Engines

**NUMBER:** 02-143-13R

**SUBJECT:** Surface Treatment Change To Oil Control  
 Piston Rings

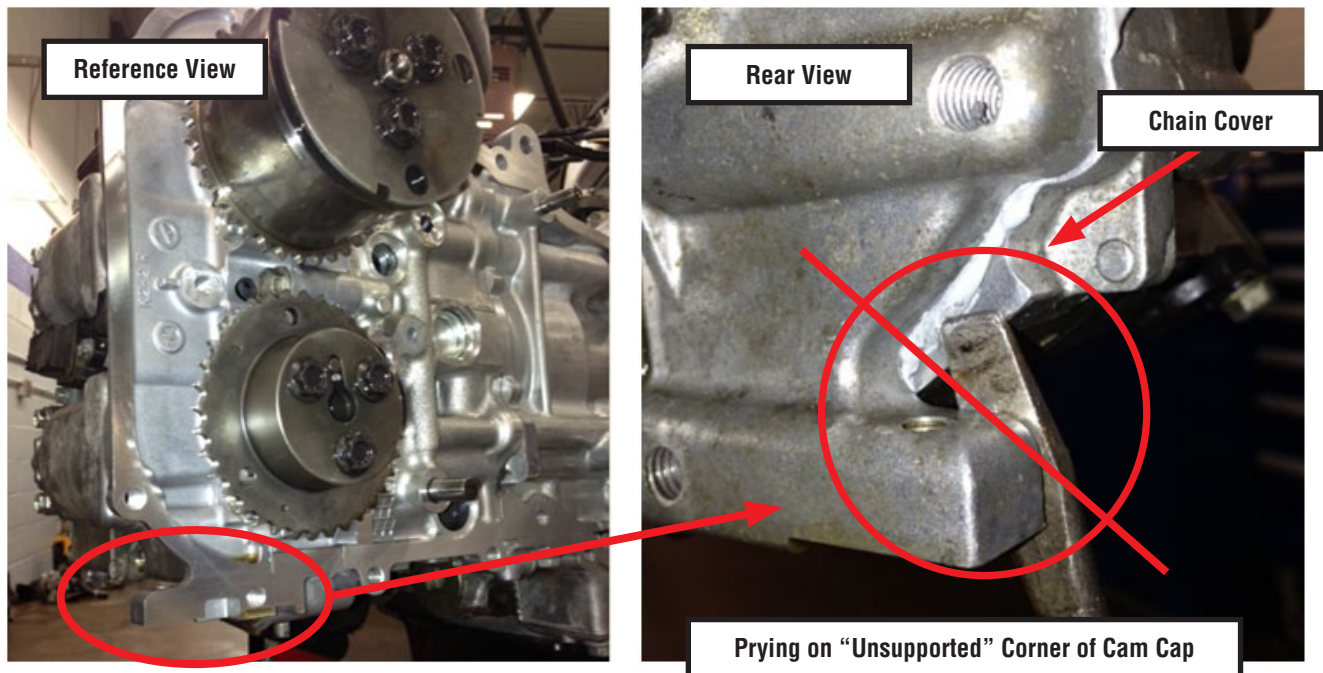
- **IMPORTANT:** After all 32 bolts securing the chain cover are removed, be **VERY** careful where you pry and what you pry on to break the silicone sealant bond. The photos below show an example of where NOT to pry. In this case, the cam cap became cracked requiring a complete cam carrier replacement. Patience is the key!
