## SERVICE BULLETIN

**APPLICABILITY:** 2014 Foresters Produced Prior to June 20, 2013 and equipped with Fujitsu-Ten (F10) Audio / Navigation System that include Subaru STARLINK™ / Aha™

**NUMBER:** 15-166-13R  
**DATE:** 11/13/13  
**REVISED:** 12/11/13

**SUBJECT:** Customer Satisfaction - Navigation SD Card Update Program

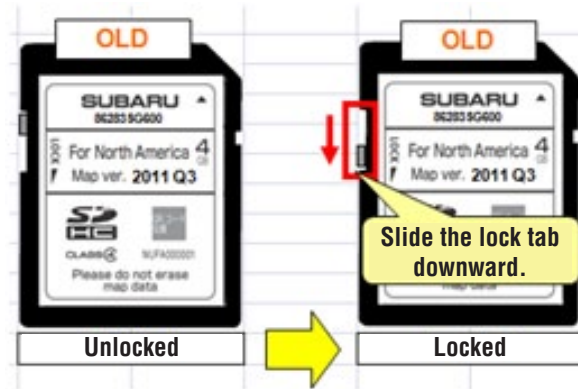
- To distinguish between the old and the new SD cards, slide the lock tab downward on the old card as shown in the illustration below, right.

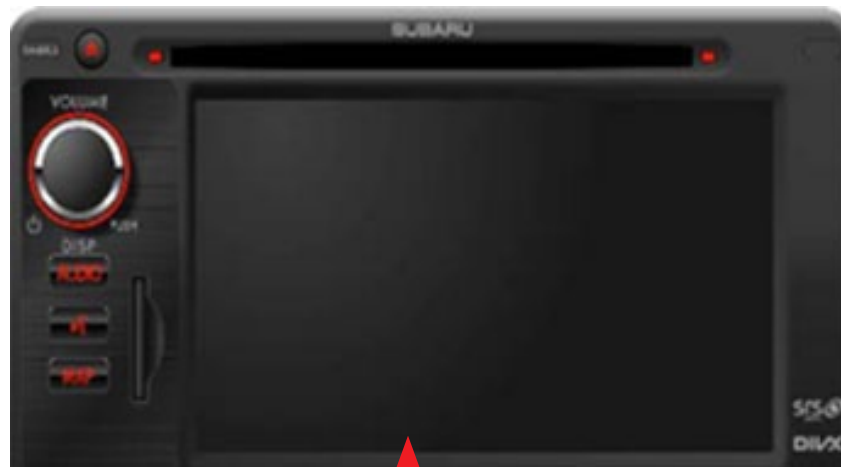
Blank Screen

8. After the Push Start Button (or key) has been switched to “ACC”, reprogramming will start automatically and continue for approximately one minute. During this time, the display screen will be blank.

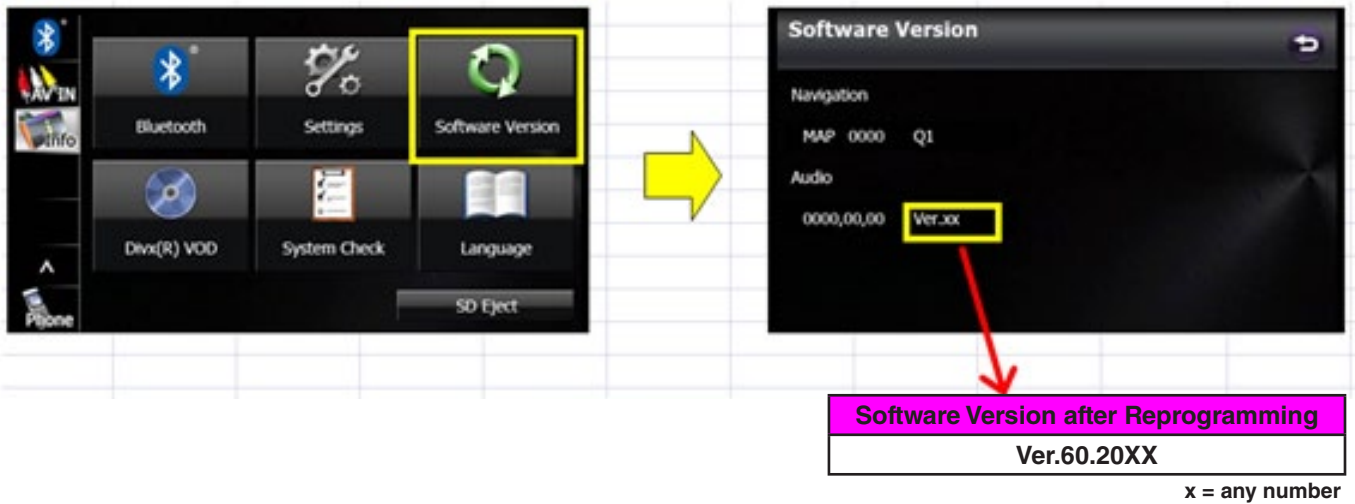
13. Press “Software Version” and verify the proper version has been installed.

If the software version number differs from what is shown above, repeat the reprogramming procedure.
