SERVICE BULLETIN

APPLICABILITY: 2013-14MY BRZ

NUMBER: 12-160-13

SUBJECT: Cracked Rear Combination Lamps

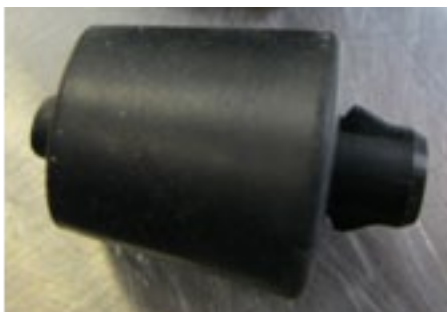
OLD

A liner was added into the weatherstrip for increased resistance to crush and the trunk stopper's overall height was increased by 2.7mm to minimize the chance of trunk lid contact with the combination lamps.
