## SERVICE BULLETIN

**APPLICABILITY:** 2013MY Legacy and Outback 2.5L Models  
 2012-13MY Impreza 2.0L Models  
 2013MY XV Crosstrek  
 2011-2014MY Forester NA Models Only  
 2013MY BRZ

**NUMBER:** 11-130-13  
**DATE:** 04/05/13

**SUBJECT:** Difficulty Starting, Rough Idle, Cam Position or Misfire DTCs  
 P0340, P0341, P0345, P0346, P0365, P0366, P0390, P0391,  
 P0301, P0302, P0303 or P0304

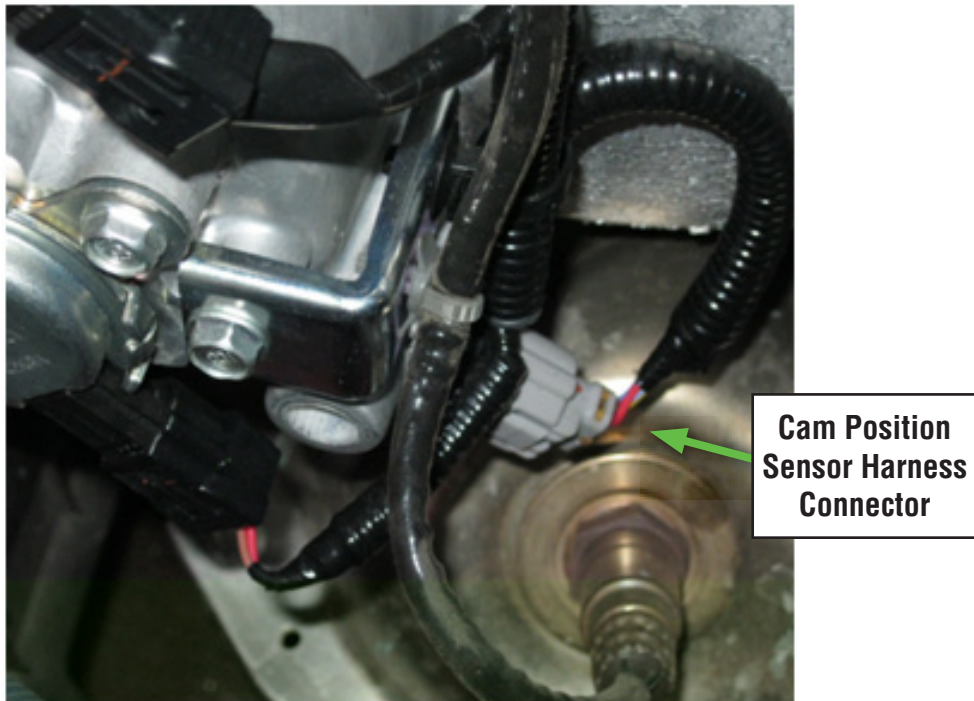
In the event you have a DTC stored for an exhaust camshaft position sensor, the repair procedure has been revised. Due to the position of the right-hand (Bank 1) sensor, measurement of the gap without removing the front catalyst is extremely difficult as shown in the photo below.

1. Confirm the irregular oscilloscope pattern for the corresponding DTC stored.
2. Remove the sensor from the timing cover and install a .2mm thick shim from the applicable kit.
3. Reinstall the sensor, torque the sensor retaining bolt to 6.4 Nm (4.7 ft. lbs. or 56.4 inch-pounds) then recheck the oscilloscope pattern.

If the pattern is normal, the repair is complete. If the irregular pattern persists, repeat Steps 2 and 3 after removing the .2mm shim and installing a .3 mm thick shim. **ONE SHIM ONLY, NO STACKING.** Repeat as necessary increasing the shim thickness .1 mm at a time until a normal scope pattern can be verified.
