SERVICE BULLETIN

APPLICABILITY:	2012MY and Later Impreza Models with FB Engine 2011MY and Later Forester, N/A and Turbo Models	NUMBER: 02-141-13 DATE: 05/28/13
SUBJECT:	Design Change to Rubber Sealing Cap for Oil Pressure Switch

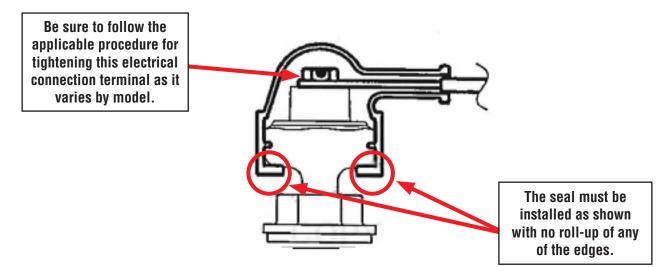
This Bulletin provides information regarding a design change to the rubber cap which covers the electrical connection at the oil pressure switch. The new cap provides better sealing and resistance to moisture intrusion which can compromise the electrical connection and in some cases, cause the oil pressure warning lamp to illuminate in error.

Follow the procedure in the applicable Service Manual if replacing the oil pressure switch. Be sure to follow the proper torque procedure for both the switch **and** the electrical connection where applicable as it varies by model. The rubber material used to make the cap is soft and pliable enough so the wire and terminal eyelet can be pushed through the "tube" portion easily. Use a little bit of dielectric grease on the terminal eyelet as a lubricant if necessary. Confirm the new rubber cap is installed as shown in the illustration above with no roll-up of the bottom sealing edges.
