SERVICE BULLETIN

APPLICABILITY: 2013MY Impreza 2.0L NA Models
 2013MY XV Crosstrek™

NUMBER: 11-127-13R

SUBJECT: ECM Reprogramming Availability for DTCs
 P0017 & P0019

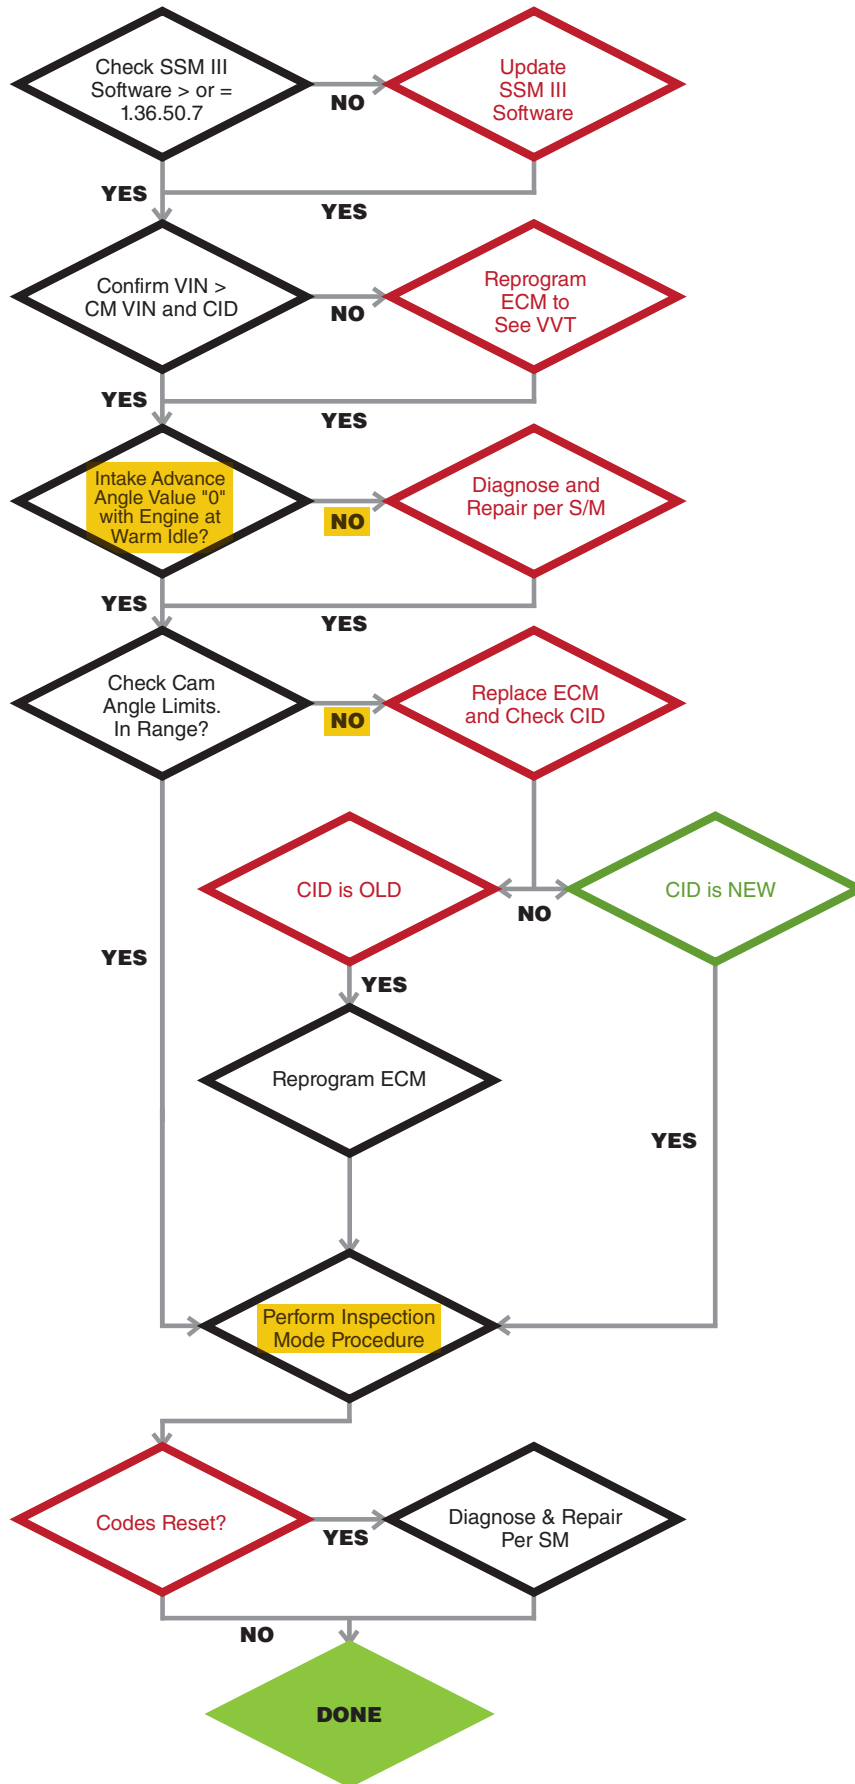
Intake Flow Chart

For the **INTAKE**, the chart above shows values within the Specified Limits (number crankshaft angle degrees) which are a **MINIMUM of 50** and a **MAXIMUM of 70**. Check the SSMIII data for VVT Advance Angle Amount as shown below.

With the engine at idle and at operating temperature, this value must be “0”. If confirmed to be “0”, proceed with the remaining steps on the INTAKE Flow Chart. If not “0”, diagnose and repair the VVT system per the Service Manual.

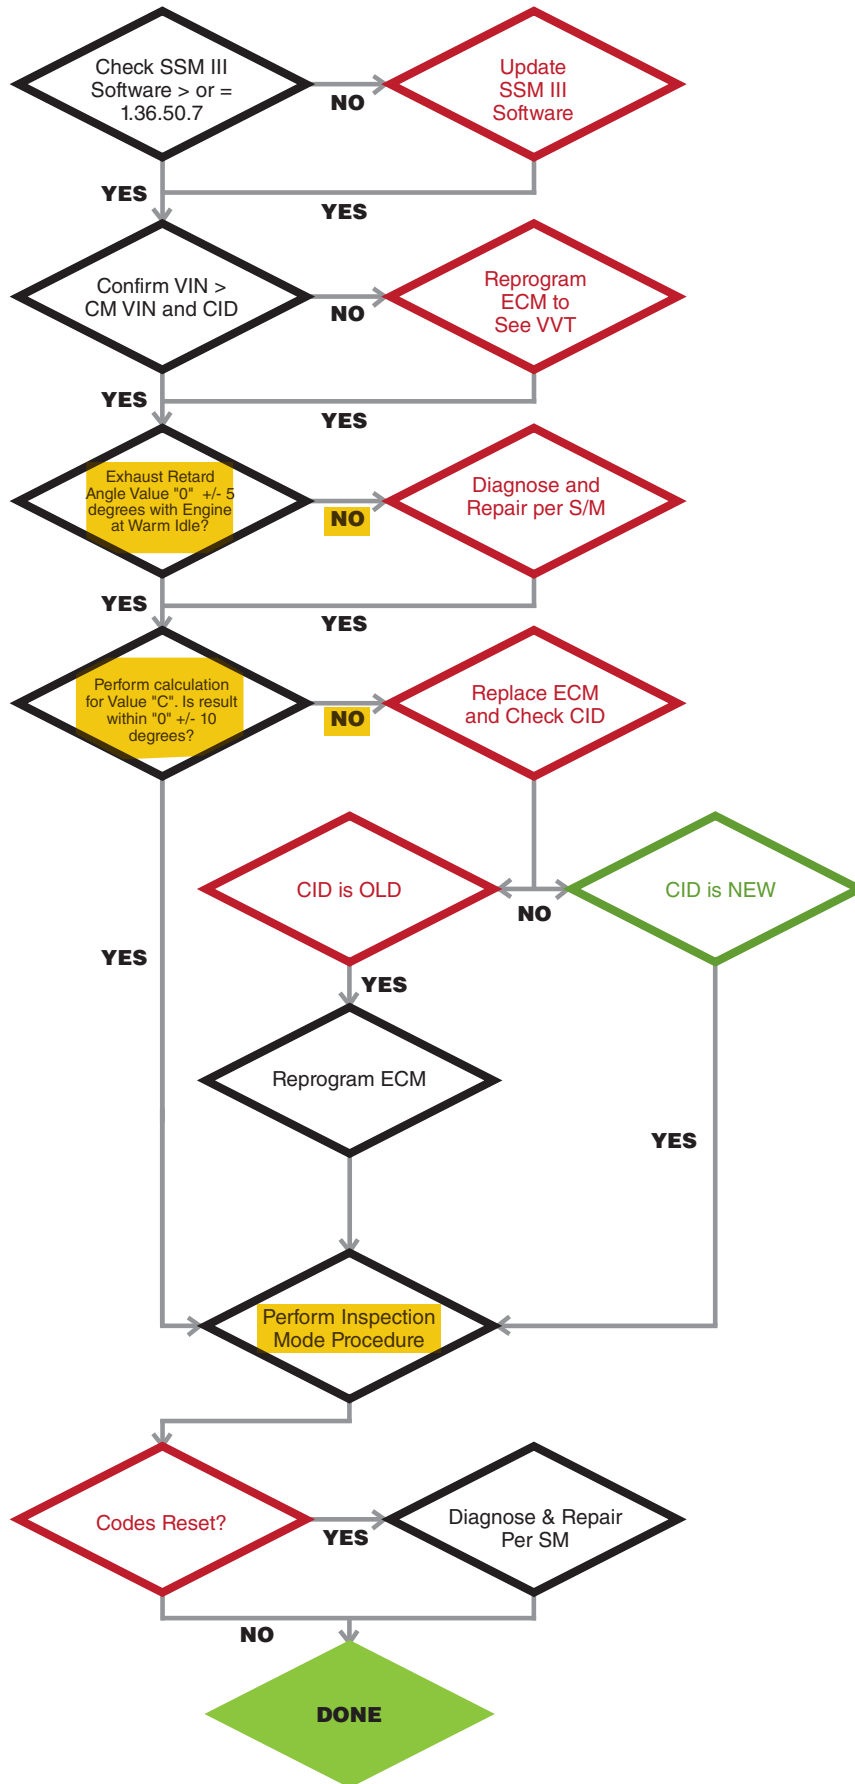
Exhaust Flow Chart

For the **EXHAUST**, the formula shown below must be used to determine if an ECM replacement is needed. Check the SSMIII data for Exhaust VVT Retard Angle as shown below. The specified range for this value is “0” +/- 10 degrees.

- **A=** Exhaust VVT Retard Angle Value, read with the engine at idle and at operating temperature (This value may be a positive or negative number.)
- **B=** VVT Exhaust Initial Position Learning Value
- **Formula: C = A + B - 90** (The 90 value in the formula represents the midpoint of the Specified Limit range.)

Does the value of C = “0” +/- 10 (degrees)?

1. **Yes-** Perform Inspection Mode and if no DTCs reset, the car is repaired.
2. **No-** Replace the ECM then follow the remaining steps on the Flow Chart.
