SERVICE BULLETIN

APPLICABILITY: 2012-13MY Impreza 2.0L 4-Door Sedan Models

NUMBER: 07-78-13R

SUBJECT: Insect Entry into Rear Combination Lamps

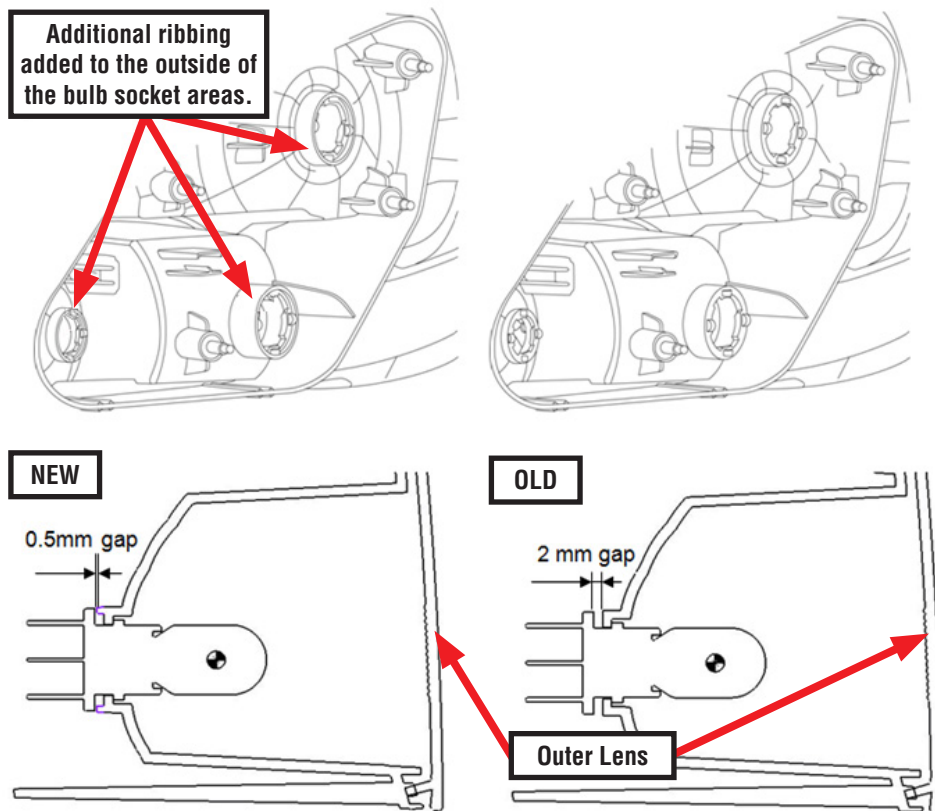
In the event of a customer concern regarding insects found inside the rear combination lamps, a countermeasure lamp assembly is now available to prevent the intrusion. The new combination lamps have an additional lip molded around the three bulb socket areas which decreases the gap between the socket and the housing from 2mm to 0.5mm.

The countermeasure combination lamps were incorporated into production 6/20/2013. Reference illustrations below show the difference between the old and new style combination lamps.
