SERVICE BULLETIN

APPLICABILITY: 2013MY XV Crosstrek
2012MY-2013MY Impreza 2.0L Models

SUBJECT: “Reed-Type” Wind Sound from Front Windshield Molding

NUMBER: 12-155-13R
DATE: 10/03/13
REVISED: 10/16/13

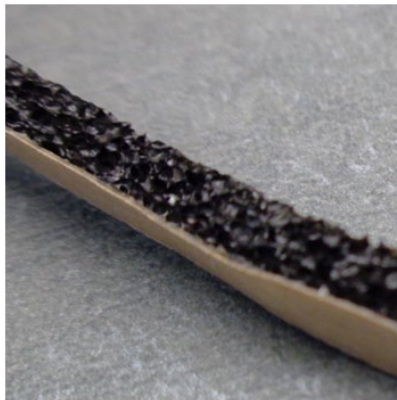
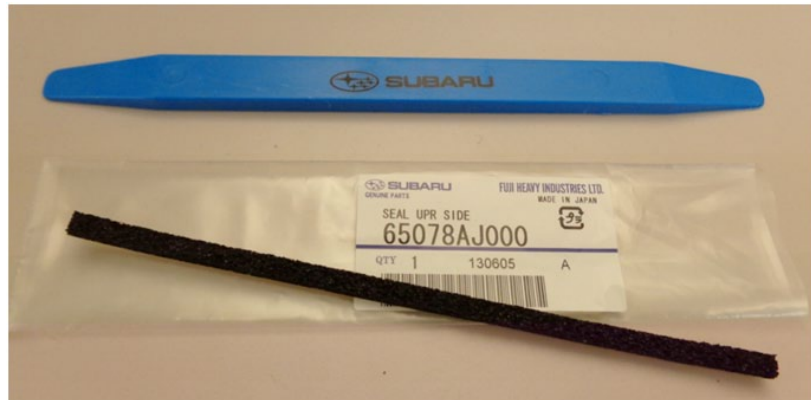
The photos below show the EPDM foam strip and for a size reference, a plastic trim tool which will be used to help lift the seal lip and gain access to the body gap where the foam strip will be installed.

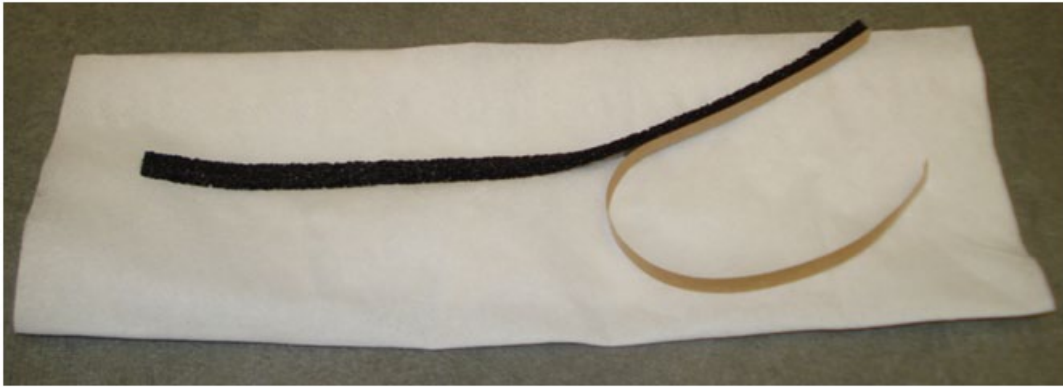
Peeling the backing and sticking the foam to a tissue

The foam strip has a backing which must be removed to expose its adhesive. The adhesive must be “neutralized” by sticking it to a facial tissue (or equivalent) then peeling it off before beginning the installation otherwise it will stick to the vehicle body or the weatherstrip.

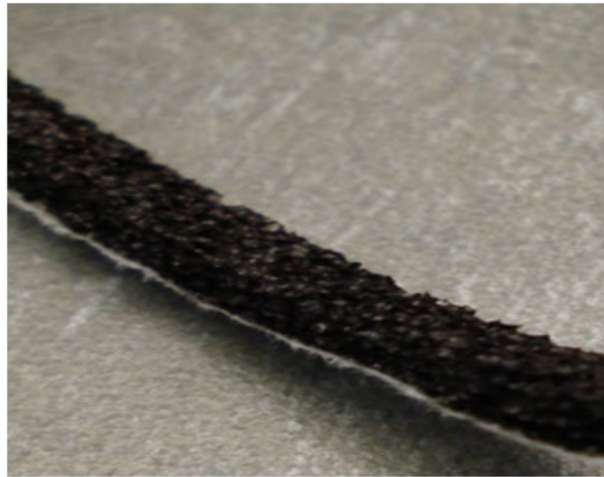
Foam after removing it from the tissue and pulling off the excess paper
