Tech Tips

Date: January 18, 2013

2008-2014 Vehicles with CCTA or CBFA 2.0T TSI Engine – Crank Gear/Timing Chain Service Tip

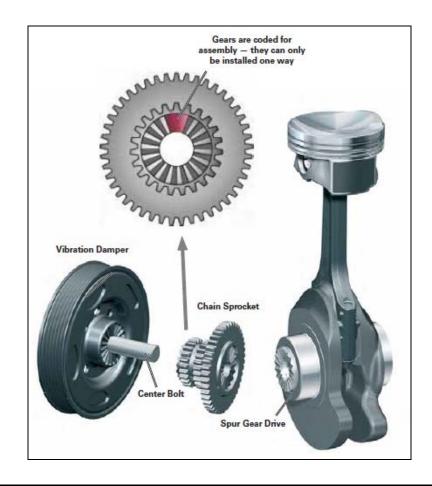
When servicing the timing chain sprocket or removing the vibration damper, be aware that one bolt holds both the vibration damper (harmonic balancer) and the crankshaft timing chain sprocket to the crankshaft. Once the damper is removed, the crankshaft should not be rotated unless special tool spacer T10368 has been installed. The crankshaft timing chain sprocket and spur gear drive on the crankshaft have a coupling that must be seated correctly during assembly. Failure to install special tool spacer T10368 before rotating engine will cause the engine to skip time and bend valves.
