Technical Bulletin

21 13 02 December 3, 2013 **2024061** Supersedes T.B. V211202 dated August 27, 2011 to include MY 2014 vehicle applicability.

Rattling Noises from Engine Compartment Area or Exhaust System

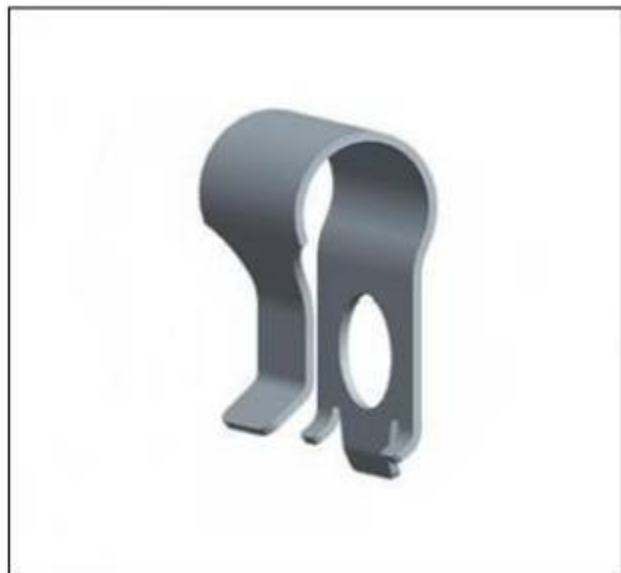
Figure 1

Because of exhaust gas pulsations the wastegate flap and actuator rod vibrate at the introduction of boost pressure

3. Once you have confirmed and familiarized yourself with the noise, attach retaining clip Part No. 06J145220A (figure 1).
