# Technical Bulletin

**01 13 33** October 23, 2013 **2034898** Supersedes T.B. V011330 dated September 4, 2013 to adjust the labor time for Beetle Convertible.

**MIL ON, DTC P0401 Exhaust Gas Recirculation Flow Insufficient Stored in ECM Fault Memory, Could be Accompanied with Fault P2463 DPF Soot Accumulation**

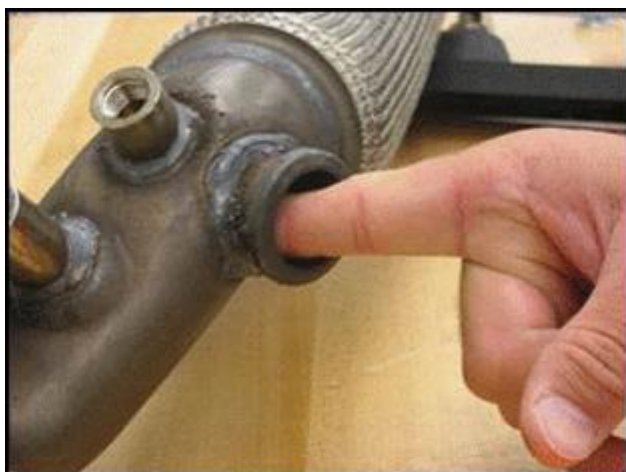
Figure 1

High soot loads prior to regeneration can cause possible restrictions in the EGR filter.

- Remove the EGR filter from the DPF and swipe the inside of the exhaust pipe at the EGR filter connection point using a clean cloth or your finger. See figures 1 and 2 below.

If your finger or the cloth comes out with black soot, replace the DPF & EGR filter together.

When replacing the DPF for the fault P0401 it is important to replace both the DPF and the EGR filter together, as soot accumulation in the EGR filter is undesired. It is NOT necessary to replace any other components for this fault (i.e. NOx Storage Catalyst, Sulfur Catalyst, Exhaust Flap, EGR Cooler), these components should be reinstalled in the vehicle with the new DPF and EGR filter.
