# Service Bulletin

File in Section: 02 - Steering  
Bulletin No.: 12-02-32-004A  
Date: April, 2013

**Subject:** Diagnostic Tips for Steering Gear Boot Stains, Perceived Fluid Leak from Power Steering Gear End Seals

**Models:** 2008-2013 Buick Enclave  
2009-2013 Chevrolet Traverse  
2007-2013 GMC Acadia  
2007-2010 Saturn OUTLOOK

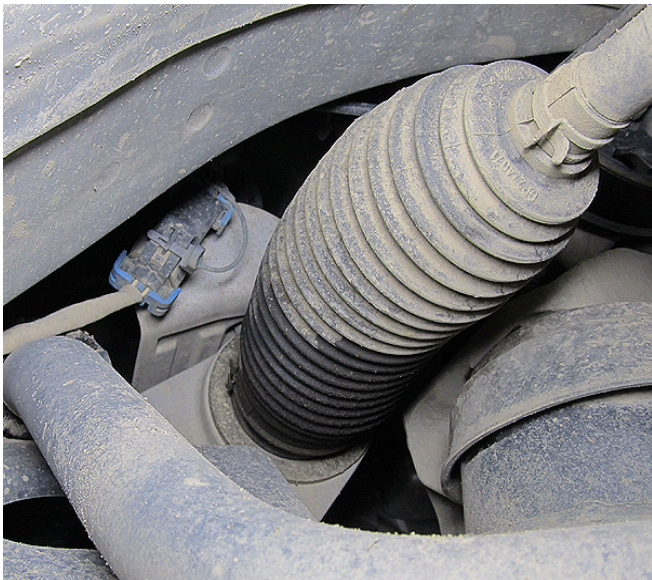
3351767

Technicians may notice a stain or shadow on the lower side of the steering gear boot bellows. These stains may be diagnosed as a leak from the rack housing end seals, allowing the fluid to leak into the boot and creating the stain.

Analysis has revealed that the stain is due to the gear assembly grease becoming liquefied from heat and collecting in the bellows of the boot causing the stain. This staining should be considered normal, especially for the RH boot, which is closest to the exhaust.

Do not replace the steering gear for this staining unless the vehicle has evidence of a loss of fluid from the pump reservoir with no external leaks.
