Recall Bulletin

PRODUCT SAFETY RECALL

SUBJECT: Driver Door Switch Short Circuit

MODELS: 2006-2007 Buick Rainier
2006 Chevrolet TrailBlazer EXT
2006-2007 Chevrolet TrailBlazer
2006 GMC Envoy XL
2006-2007 GMC Envoy
2005-2007 Saab 9-7X

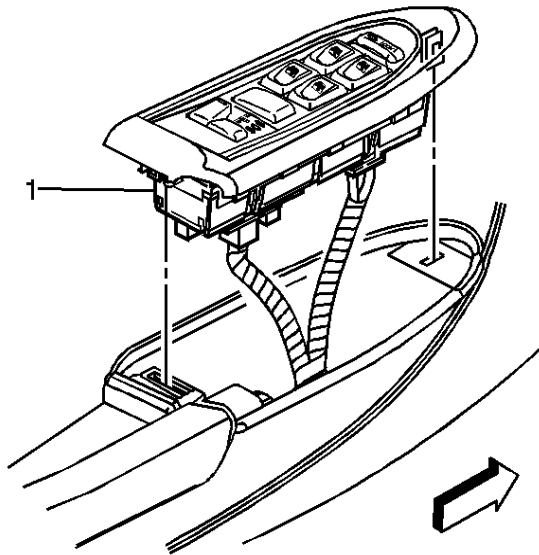
690976

1. Perform a functional test on the driver side door lock and side window switch. Test all switch functions to ensure the driver side door lock and side window switch functions as designed.
 - If the driver side door lock and side window switch passes the functional test, proceed to Step 2.

- If the driver side door lock and side window switch does NOT pass the functional test, replace the driver side door lock and side window switch. Refer to *Door Lock and Side Window Switch Replacement - Driver Side* in SI.

2. Remove the driver side door lock and side window switch. Refer to *Door Lock and Side Window Switch Replacement - Driver Side* in SI.
