# Recall Bulletin

## PRODUCT SAFETY RECALL

**SUBJECT:** Driver Door Switch Short Circuit

**MODELS:** 2006-2007 Buick Rainier  
2006 Chevrolet TrailBlazer EXT  
2006-2007 Chevrolet TrailBlazer  
2006 GMC Envoy XL  
2006-2007 GMC Envoy  
2005-2007 Saab 9-7X

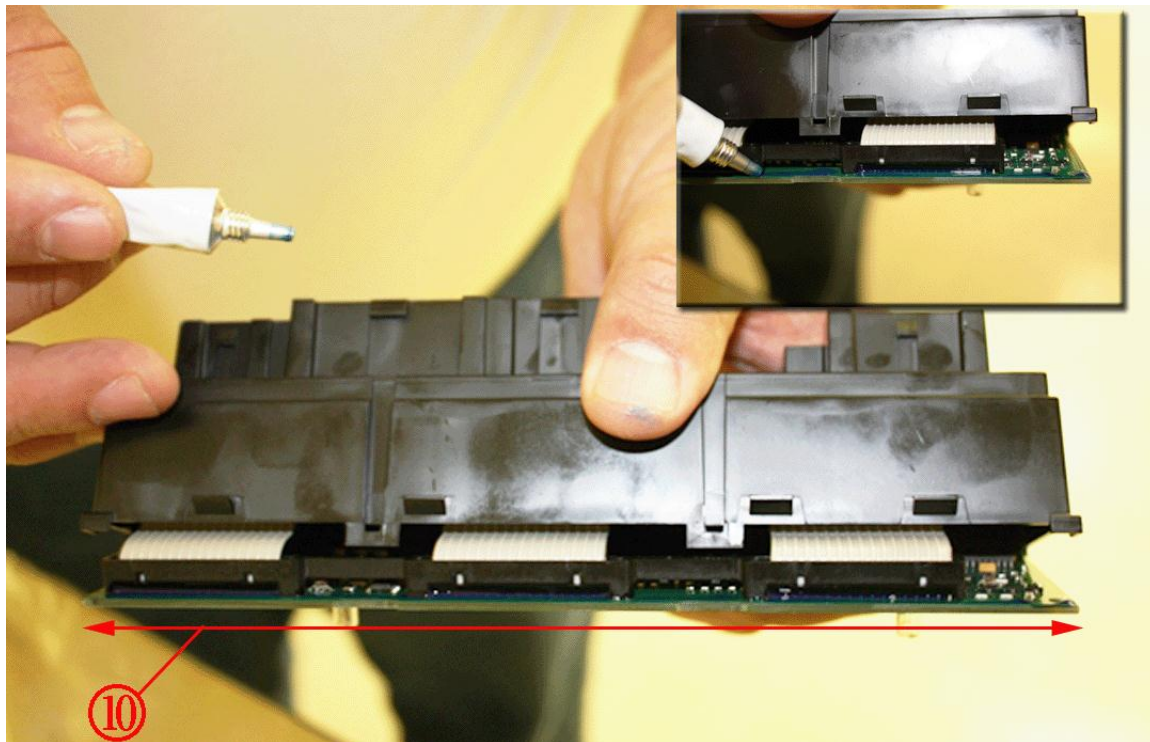
2917382

Top “A” and bottom “B” views of the contact board include examples of connector (4), connector pins (3), traces (2), and vias (1).

- 10. Ensure the protective coating covers the connector pins, traces and vias (holes) in the application area of the contact board.

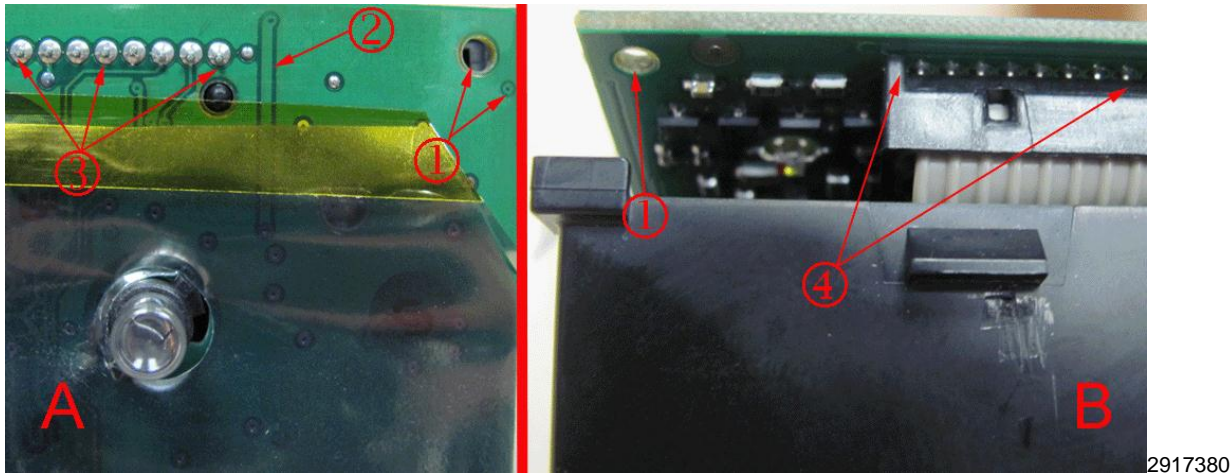
Top “A” and bottom “B” views of the contact board include examples of connector (4), connector pins (3), traces (2), and vias (1).

- 11. Apply the protective coating to the bottom side of the contact board. Apply the protective coating over the entire length (10) of the contact board.

12. Ensure the protective coating covers the connector pins, traces and vias (holes) in the application area of the contact board.
