GM Bulletin No.: 12259

SUBJECT: Service Update for Inventory and Customer Vehicles

Intermittent, Partial, or No Power Glove Box Function

MODELS: 2013 Cadillac XTS

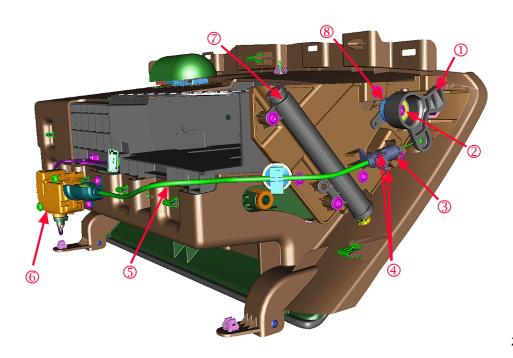
Figure 1 - XTS Power Glove Box Assembly

This bulletin provides a service procedure to inspect the glove box operation on **certain** 2013 model year Cadillac XTS vehicles. If the glove box is misaligned, has side rib interference, or cam/cable adjustment issues, it could cause the glove box to not open or release only one side when the electrical release switch is pushed.

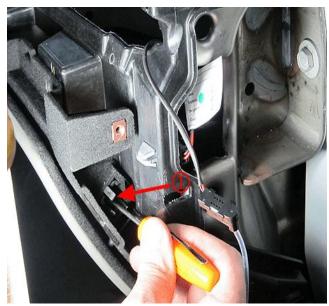
Preliminary Electrical Check

If the electrical switch is inoperative, or the glove box door is not releasing on either side, the door can be opened by inserting a small screwdriver, or similar tool, into the right side latch opening (1) and manually tripping the release.

Operate the glove box door electrical switch and listen for the sound of the actuator motor cycling.

- If you can hear the actuator cycling, move to Step 1 of the repair table below to verify if further repairs are necessary.
- If you cannot hear the actuator cycling, inspect the electrical connections to verify power to the glove box door actuator. Re-try the door after power to the actuator is established. If the door opens/unlatches, move to Step 1 of the repair table below. If power is verified and the actuator does not function, refer to I/P Compartment Door Latch Release Malfunction in SI.

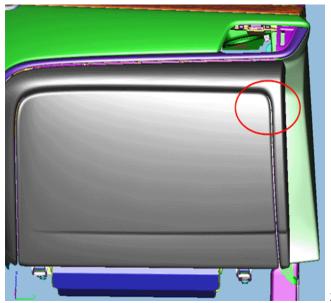
Figure 2 – Latch Engagement Outboard Top Corner of Glove Box

2	If the outboard top corner of the glove box is rearward of the surrounding surface, verify lack of latch engagement by pulling on the corner of the glove box (see Figure #2). Does the outboard corner of the door easily move rearward?	For vehicles built prior to October, 15 2012 Go to Step #3 For vehicles built on or after October, 15 2012 Go to Step #8	Go to Step #4
3	Complete the following lower air bag/bracket adjustment procedure (see Figure #3): • Remove the right side I/P insulator (hush) panel and 2 retaining screws. • Loosen the two nuts (1) that attach the passenger side lower air bag module (2) and support bracket (3). • Push the bracket and air bag as far to the right (outboard) as possible. • Rotate the bracket by pushing the bracket forward in vehicle on the right side and pulling rearward on the left (inboard) side. • While still holding the bracket in this position, re-tighten the two nuts. • Re-install the hush panel and screws. Re-try the door. Does the door latch completely?	Go to Step #4	Problem is inside the sealed door assembly and cannot be repaired. Go to Step #15
