Service Bulletin

Bulletin No.: PIT5216

Subject: Intermittent IPC Indicators On Radio Display Blank Low Speed LAN Communication Issues DTC

Models: 2013 Chevrolet Equinox
2013 GMC Terrain

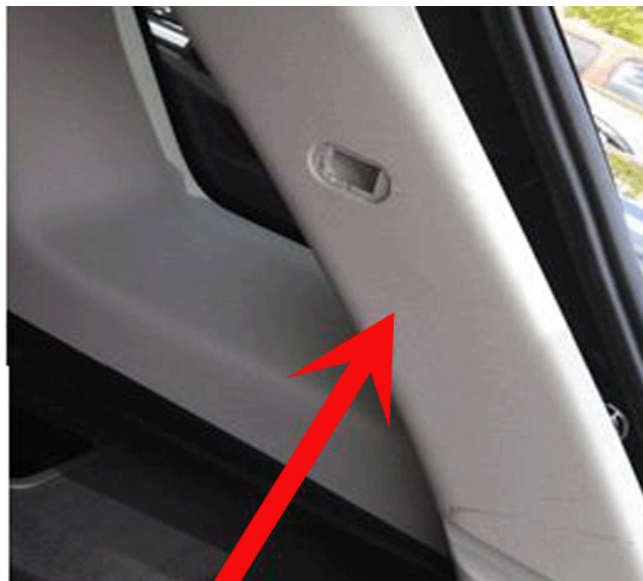
To gain access to X401 pull the passengers D pillar trim back.

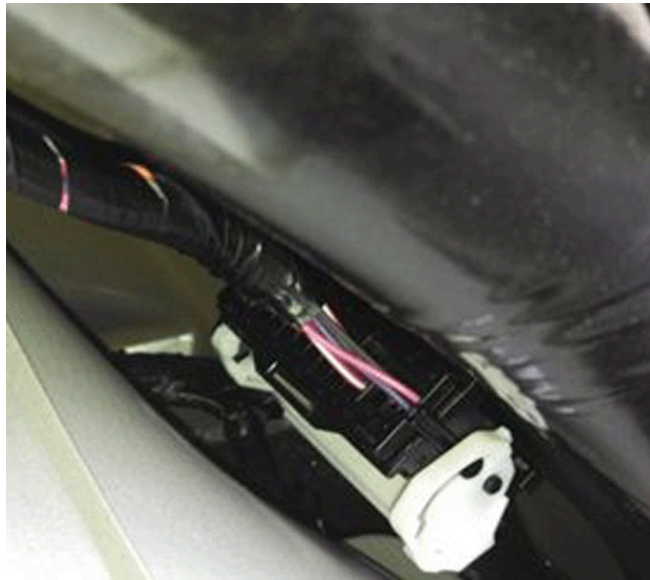
3468552

Locate X401 behind the D pillar.

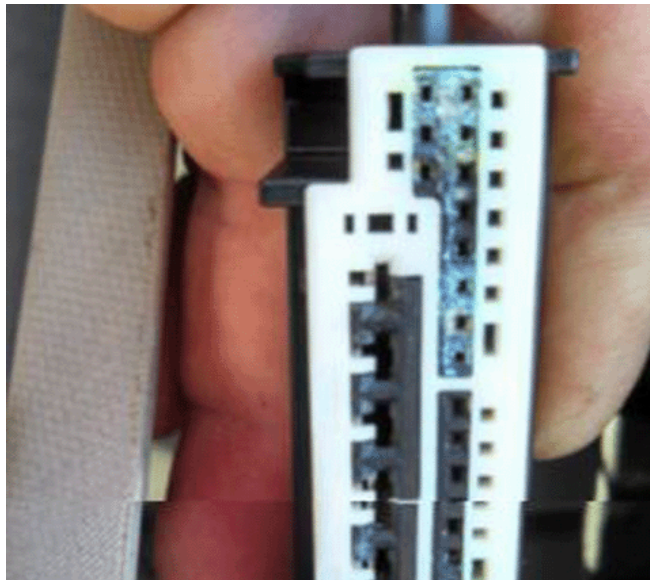
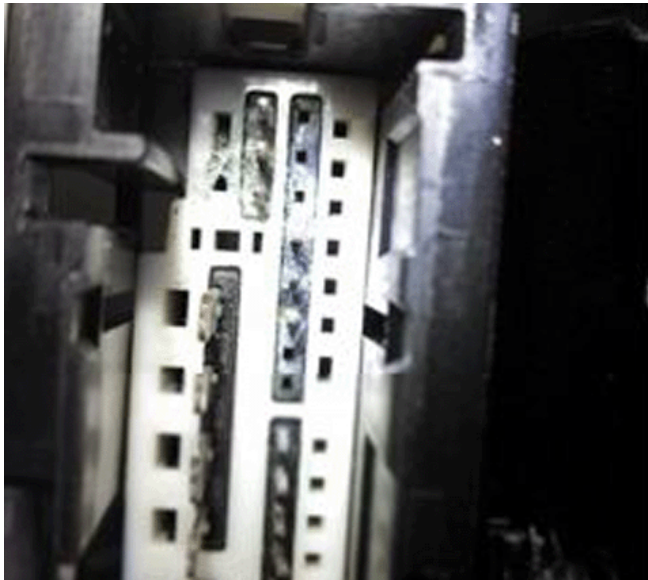
Inspect the connector X401 for terminal corrosion due to water intrusion. X401 terminal 12 circuit 24 may have a short condition between the backup camera input and the low speed data line circuit 5060 (terminal 14) to voltage when moisture was present in the connector and when shifted into reverse. Other circuits were also found corroded, but did not directly affect the customer's concern with the IPC and radio.

Disconnect X401 and check for corrosion.

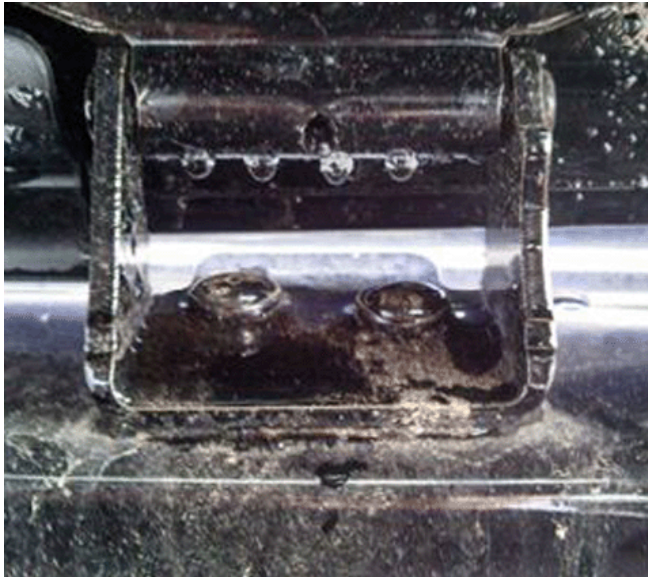
3468556

Water test the vehicle to isolate the cause of water intrusion above the passenger's side rear of the headliner. Water test around the passenger's side of the liftgate hinge.
