Service Bulletin

Bulletin No.: PIT5226B

Subject: Rear Sliding Glass Inoperative or Noisy (Pulley Cover Separation)

Models: 2014 Chevrolet Silverado LD 1500
2014 GMC Sierra LD 1500

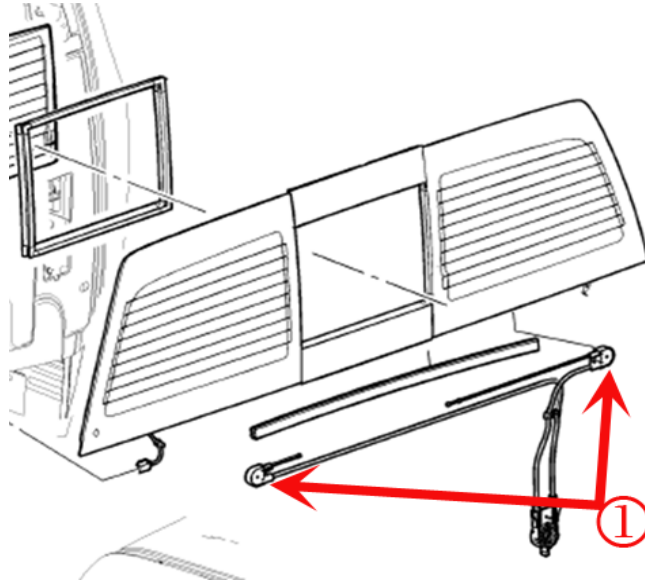
3520529

Some owners may comment on the rear sliding glass being inoperative or noisy when operated. This could be caused by the cable pulley cover becoming separated, see photos below.

Do NOT replace the complete back sliding glass assembly for this issue.
Do replace the rear sliding window regulator assembly (GM part number 23441999).

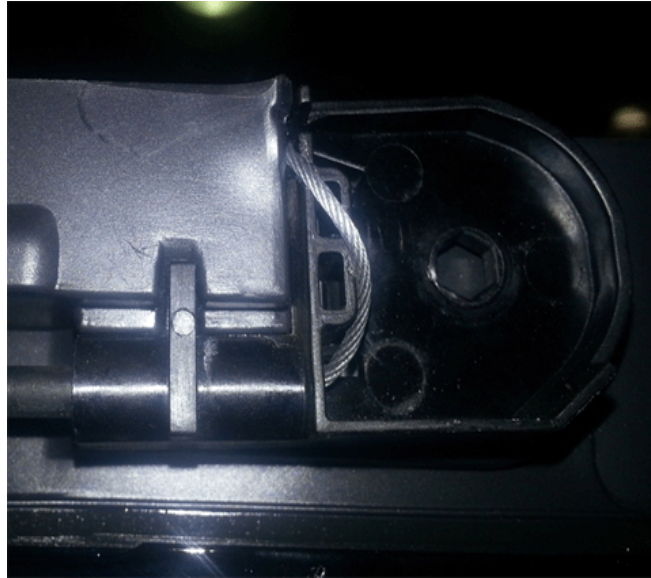
3520533

If the cable pulley cover completely disengages, the pulley can come off and cause the cable to bind, see photo below.
