Service Bulletin

Bulletin No.: PIT5244

Subject: Tailgate Makes A Pop/Click/Snap Type Noise When Opening

Models: 2014 Chevrolet Silverado 1500
2014 GMC Sierra 1500
With EZ Lift and Lower Tailgate RPO PPA

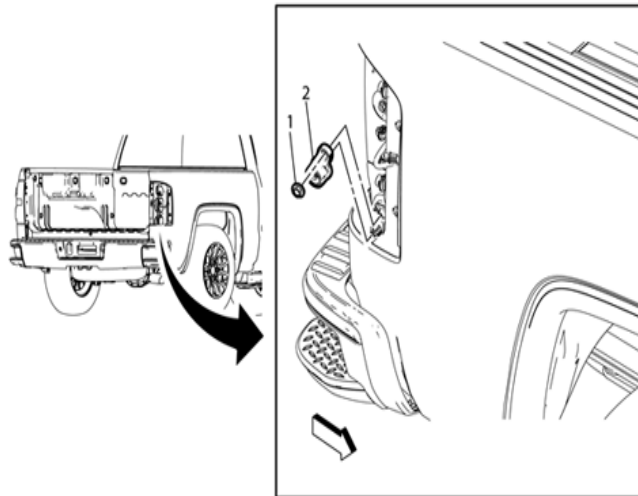
3671088

Some owners may comment there is a pop/snap/click type noise when the tailgate is opened. The noise will sound like it is from the right side hinge area. This could be caused by the tailgate dampener mounting nut not being torqued properly, as shown below.

To correct this concern, inspect the tailgate dampener mounting nut for proper torque. It should be torqued to 25 Nm (18 lb ft) +/- 3 Nm (2 lb ft).
