# Service Bulletin

Bulletin No.: 09-08-42-005D

**Subject:** Driver/Passenger Door and/or IP Accent Lighting – Light Bar (Pipe) Inoperative or Loses Intensity

**Models:** 2010-2014 Chevrolet Camaro  
Equipped with Light Piped Door Trim (RPO FCR)

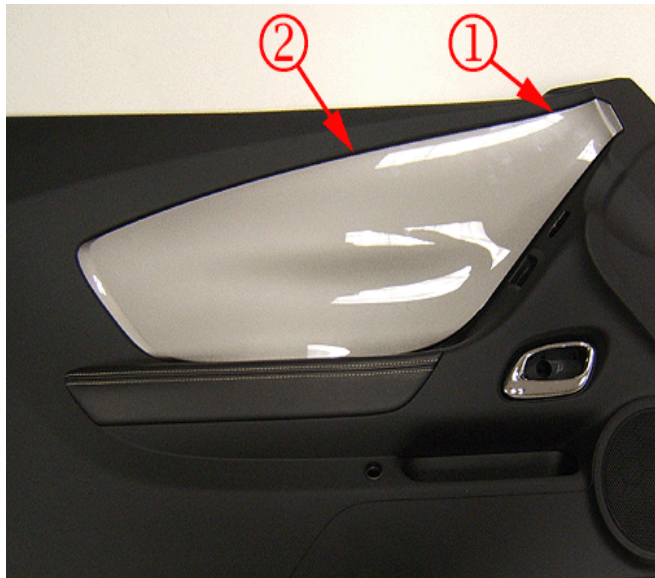
2294397

The normal operation of the door accent lighting is the light will be brightest at the rear of the door panel and gradually lose intensity until approximately 76 mm (3 in) (1) from the front edge of the trim panel. The lighting does not carry on to or across the instrument panel. If the light stops at the center of the door (2), proceed with this bulletin.

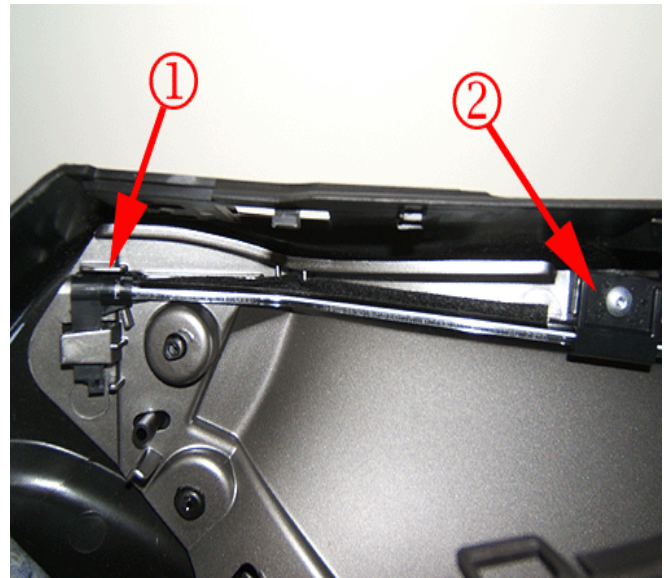
2294398

If the light stops at the center of the door, remove the trim panel and make sure the light bar (pipe):

1. Is in the channel
2. Has not dipped down
3. Is properly retained by the retaining clips (2)
4. End cap (1) is properly installed

To verify normal operation, apply 12 volts to the connector and make sure the light is brightest at the rear of the panel and gradually dims towards the front of the door panel.

If the light bar (pipe) is not illuminated the full length, is noticeably different from side to side or inoperative, replace the lamp-harness assembly. There are two different part numbers based on the illumination color of the lamp.
