Service Bulletin

Bulletin No.: 13-06-01-003A

Subject: Excessive Oil Consumption – Perform Oil Consumption Test and/or Install Piston and Piston Ring Kit

Models: 2010-2013 Buick LaCrosse
2011-2013 Buick Regal
2010-2013 Chevrolet Equinox
2010-2013 GMC Terrain
Equipped with 2.4L Engine (RPOs LAF, LEA)

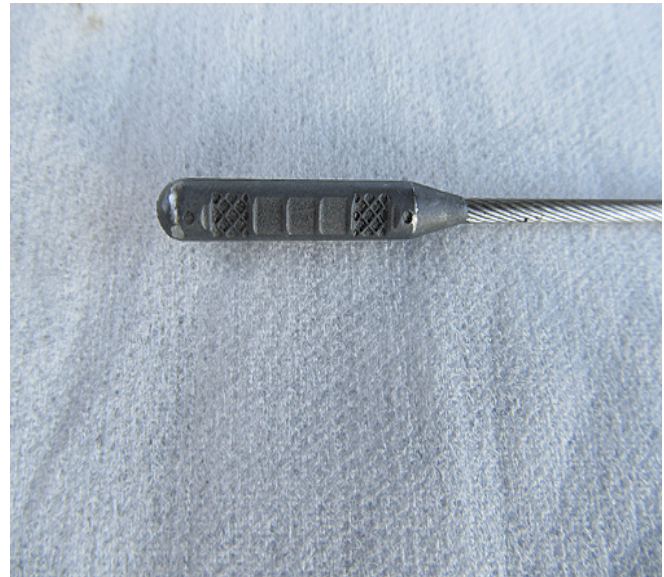
3339530

Important: When checking the oil level with the oil dipstick design shown below, please note that the oil volume per notch is not linear due to the shape of the block. The upper notches (relative to the top of the handle) equal 0.24 quart (0.227 L) between each notch while the lower notches only equal 0.14 quart (0.132 L) between each notch. As a result, no oil will appear on the dipstick if it is low on oil by approximately 1.25 quarts (1.18 L) or more. When determining the oil consumption rate, the oil volume added to return it to the starting location is the total amount of oil consumed. The consumption rate must be documented on a repair order.

Notice: Do not add too much oil. An overfill can lead to burn off of the excess oil. Advise the customer to wait until the oil is below the cross-hatched area at the tip of the dipstick before adding oil.
