Service Bulletin

SUBJECT: Service Update for Inventory and Customer Vehicles
Transmission Fluid Leak
Expires with Base Warranty

MODELS: 2013 Cadillac SRX
Equipped with 6-Speed Automatic Transmission (6T70)

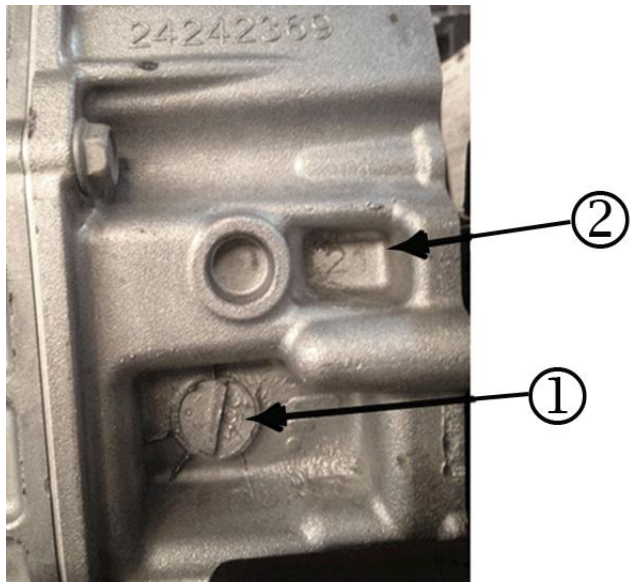
3337579

(1) Julian Date Location (2) Mold Casting Number Location

3. Locate the casting information on the torque converter housing (1) (2).

3.1 Locate the Julian date (1).

- If the Julian date is 037 or 038, proceed to step 3.2.
- If the Julian date is NOT 037 or 038, no further action is required. Proceed to step 4.

3.2. Determine the mold casting number (2).

- If the mold casting number is 11, remove and replace the transmission assembly. Refer to *Transmission Replacement* in SI. Submit a warranty claim for the transmission replacement.
- If the mold casting number is NOT 11, no further action is required. Proceed to step 4.
