Recall Bulletin

PRODUCT SAFETY RECALL

SUBJECT: Steering Wheel Fastener Inspection

MODELS: 2013 Buick Encore

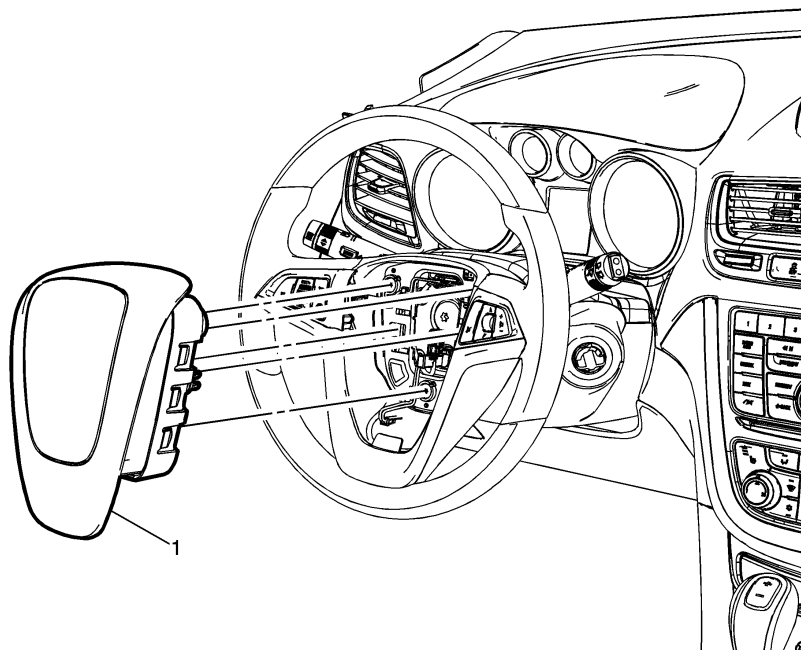
2779508

General Motors has decided that a defect, which relates to motor vehicle safety, exists in **certain** 2013 model year Buick Encore vehicles. The steering wheel fastener may not have been properly installed. If it was not installed properly, it could allow the steering wheel to come loose and/or separate from the steering column. If this were to happen while the vehicle was moving, the driver could lose the ability to steer the vehicle, potentially leading to a crash.

10. Inspect the hub area of the steering wheel for the attachment bolt (1).
- If the attachment bolt (1) is NOT present, install a new attachment bolt, P/N 11610164. Tighten the bolt to **30 Nm (23 lb-ft)**. Proceed to Step 11 after installing the new attachment bolt.
 - If the attachment bolt is present, apply a torque of 25 N·m (18 lb-ft) and verify that the bolt does not rotate. If the bolt rotates, remove it and replace it with P/N 11610164. Tighten the bolt to **30 Nm (23 lb-ft)** using a torque wrench.
