# Program Bulletin

## CUSTOMER SATISFACTION PROGRAM

**SUBJECT:** Clunking Noise When Turning

**MODELS:** 2013 Chevrolet Cruze

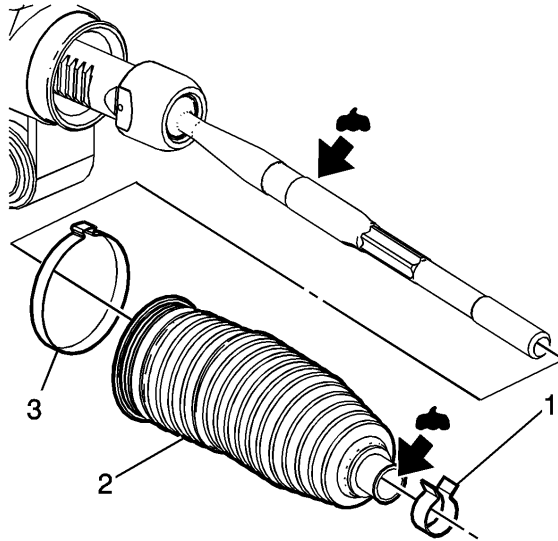
2375391

4. Remove the outer boot clamp (1). Discard the clamp.
5. Cut or otherwise remove the inner boot clamp (3). Discard the clamp.
6. Remove the steering gear boot (2). For vehicles in dealer inventory, proceed to Step 9. For customer vehicles, proceed to the next step.
