Program Bulletin

CUSTOMER SATISFACTION PROGRAM

SUBJECT: Front and Rear Door Handles May Stick or Bind

MODELS: 2013 Buick LaCrosse, Regal, Verano
2013 Cadillac SRX
2013 Chevrolet Cruze, Malibu
Equipped with Keyless Entry Feature (ATH)

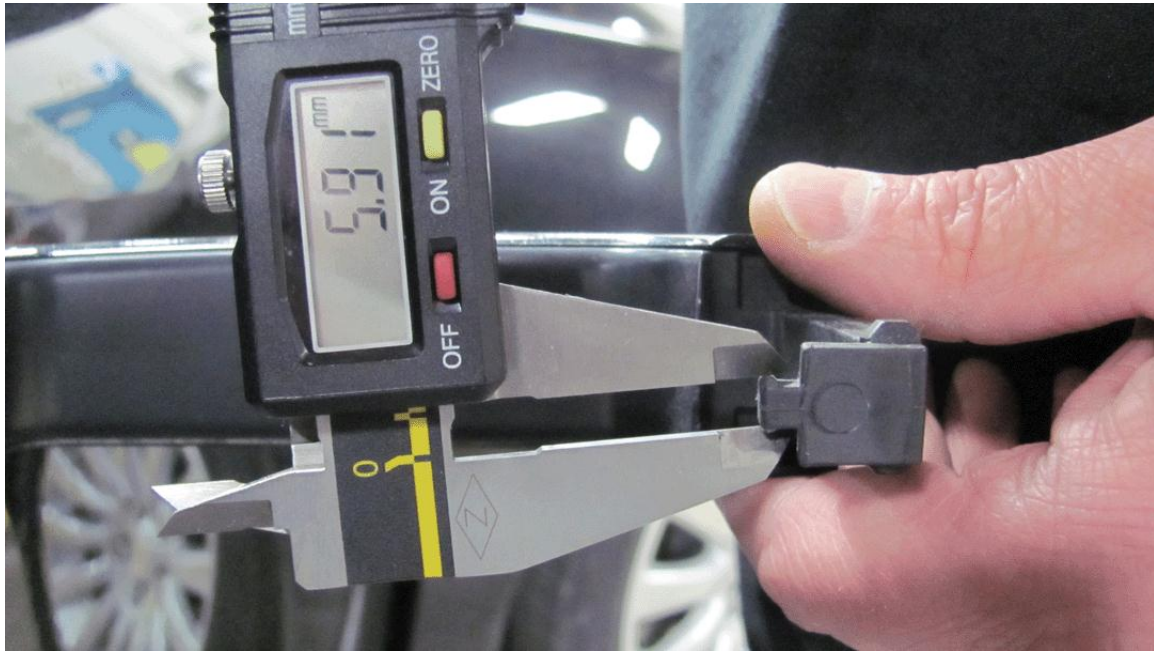
3407727

On **certain** 2013 model year Buick LaCrosse, Regal, Verano; Cadillac SRX; and Chevrolet Cruze and Malibu vehicles, equipped with the keyless entry feature (ATH), there may be an interference condition between the outside door handle and the door handle bracket assembly. This could cause the outside door handle to stick or bind in the open position when the door is opened from outside of the vehicle. If this occurs, the door may bounce back when attempting to close it. If the door does not latch, a warning chime will sound and a warning message in the instrument cluster will illuminate. Tapping on the outside door handle or closing the door with higher effort should free the door handle and allow it to latch.

7. Measure the leg of the door handle as shown. Ensure the thickness is between 5.7 mm (0.224 in) and 5.9 mm (0.232 in).
