# Recall Bulletin

## PRODUCT SAFETY RECALL

**SUBJECT:** Loss of Battery Charge – Inspect Generator Control Module

**MODELS:** 2012-2013 Buick LaCrosse, Regal  
2013 Chevrolet Malibu Eco  
Equipped with eAssist

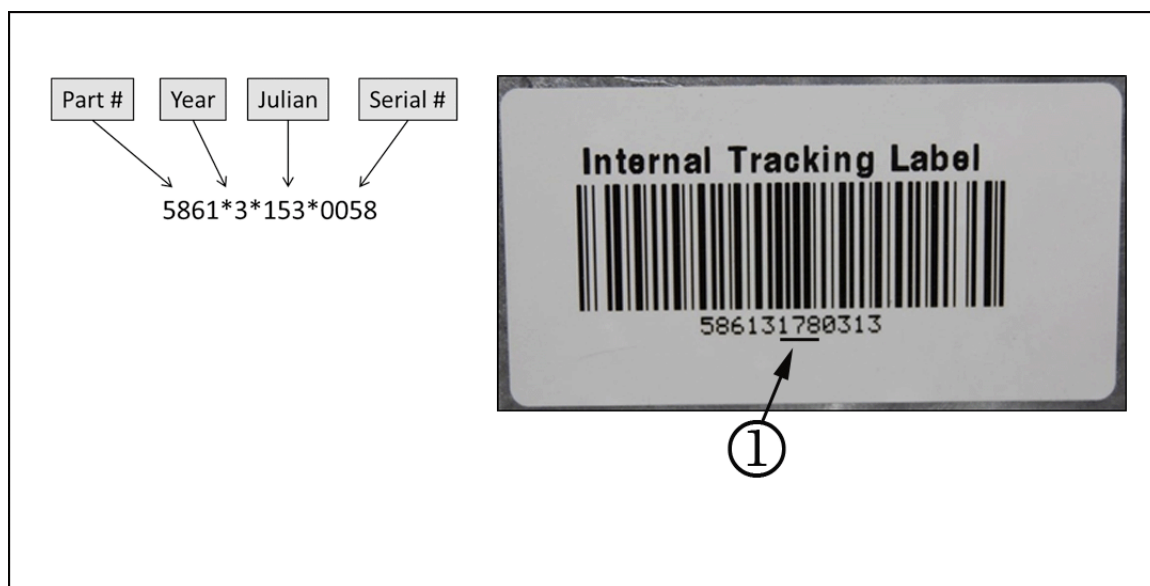
3600552

Do NOT provide technicians with GCMs (p/n 24269448 or 24266403) that have a Julian date of 171 through 199. Determine the Julian date following the steps below. Return modules that fail the inspection according to Special Return Bulletin #G\_0000171850.

2. Determine the Julian date (1) as shown above.

- If the Julian date (1) is 171 through 199, proceed to step 3.
- If the Julian date (1) is NOT 171 through 199, provide the GCM to the technician for installation in the vehicle.

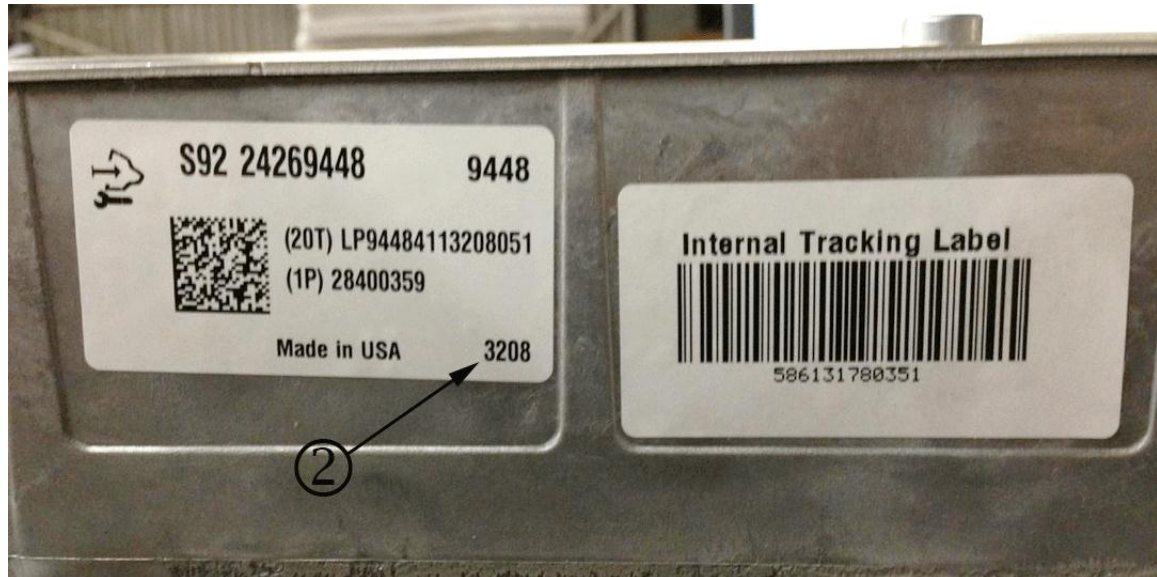
3604229

3. Locate the Flash label on the GCM.

- If the number on the lower right-hand side of the label (2) is 3203 or lower, do NOT use the GCM. Obtain another module and perform the inspection again.
- If the number on the lower right-hand side of the label (2) is 3204 or higher, provide the GCM to the technician for installation in the vehicle.

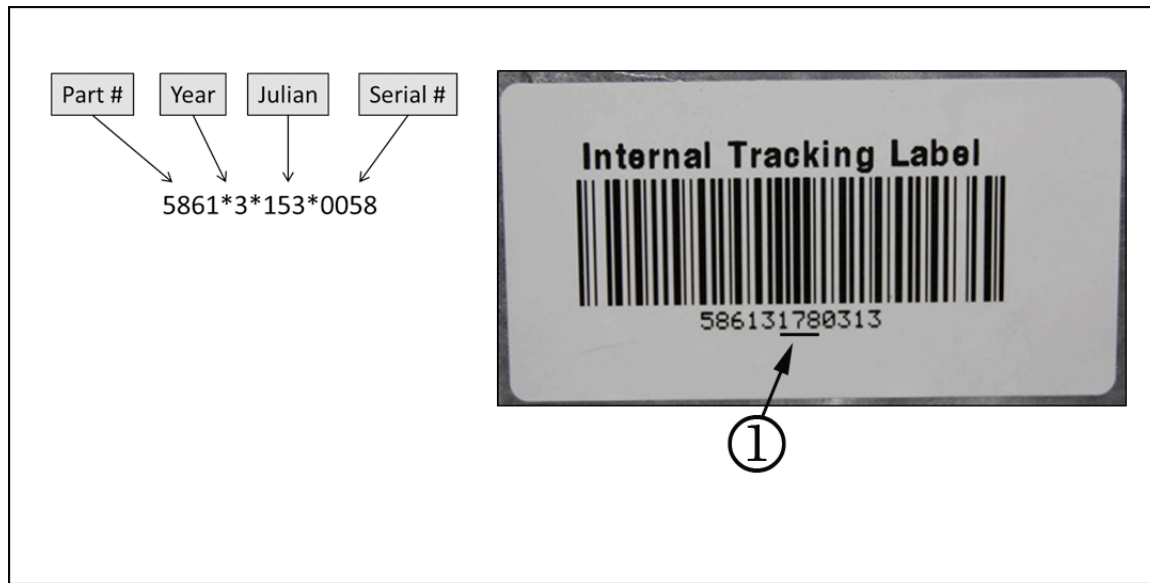
3600552

1. Locate the barcode label on the new GCM.
2. Determine the Julian date (1) as shown above.
  - If the Julian date (1) is 171 through 199, proceed to step 3.
  - If the Julian date (1) is NOT 171 through 199, install the GCM in the vehicle.

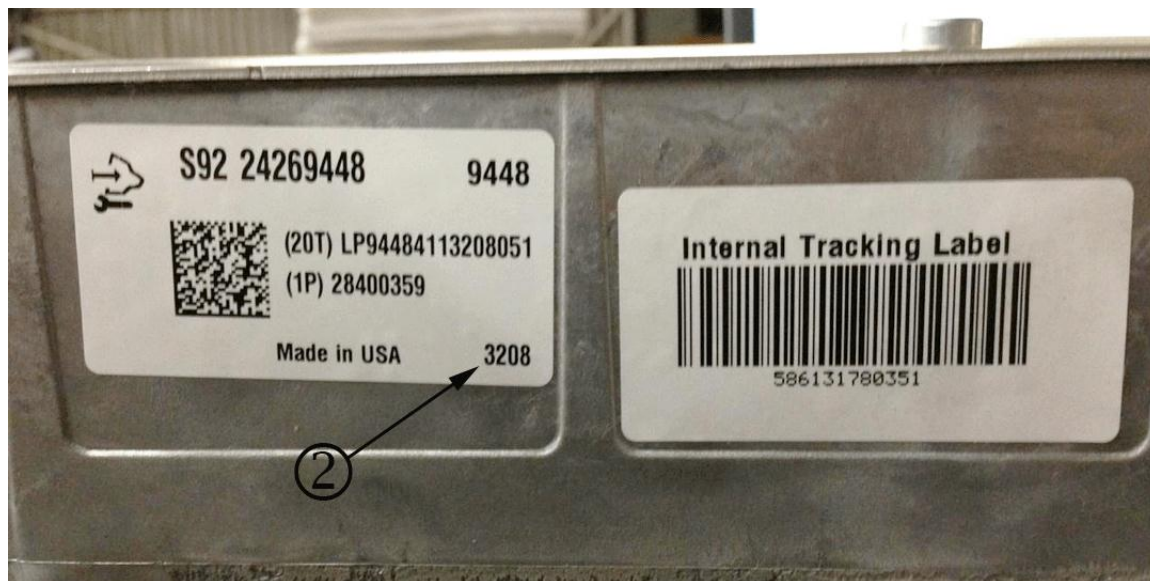
3604229

3. Locate the Flash label on the GCM.
  - If the number on the lower right-hand side of the label (2) is 3203 or lower, do NOT use the GCM. Obtain another module and perform the inspection again.
  - If the number on the lower right-hand side of the label (2) is 3204 or higher, install the GCM in the vehicle.
