Service Bulletin

SERVICE UPDATE

SUBJECT: Service Update for Inventory and Customer Vehicles
Incorrect Battery Current Sensor on Negative Battery Cable Assembly
Expires with Base Warranty

MODELS: 2013 Cadillac Escalade, Escalade ESV
2013 Chevrolet Tahoe, Suburban
2013-2014 Chevrolet Captiva, Captiva Sport
2014 Chevrolet Silverado
2013 GMC Yukon, Yukon XL
2014 GMC Sierra

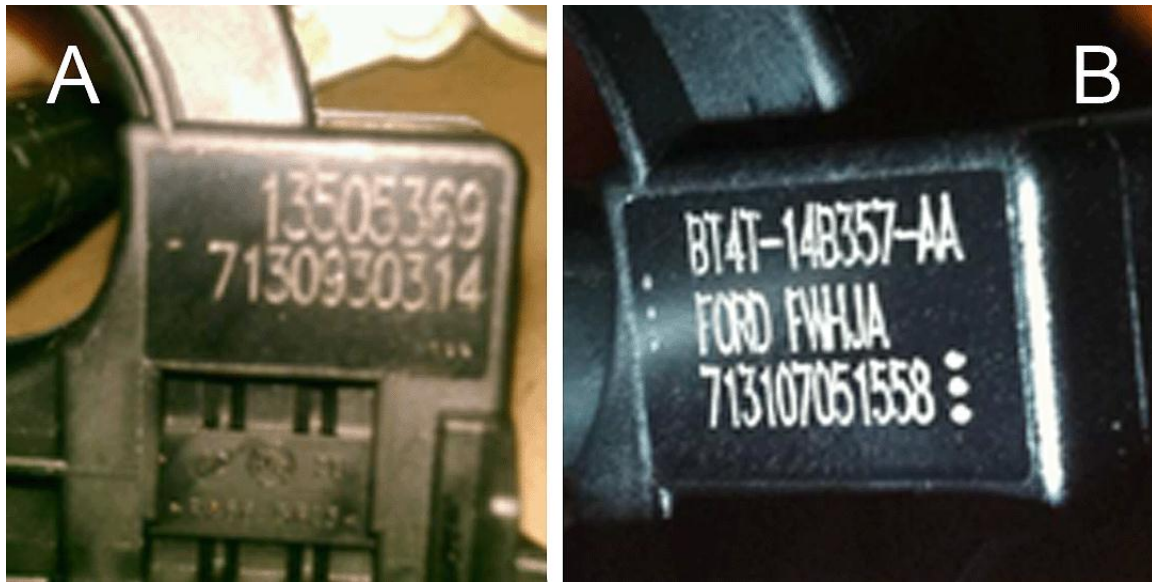
An incorrect battery current sensor may have been installed on the negative battery cable assembly. Perform the inspection procedure below to determine if an incorrect battery current sensor was installed.

Note: The battery current sensor part number is located on the backside of the sensor. Use a mirror and light to read the part number. If you cannot read the part number with a mirror and light, disconnect the sensor to read the part number. Refer to photograph. Portion 'A' of the photograph shows the correct part number for the battery current sensor. Portion 'B' of the photograph shows an incorrect part number for the battery current sensor.

3. Determine the part number on the battery current sensor.
 - If the battery current sensor part number is 13505369, the correct battery current sensor is installed on the negative battery cable. No further action is required.
 - If the battery current sensor part number is BT4T-14B357-AA, the incorrect battery current sensor is installed on the negative battery cable. Proceed to step 4.
4. Remove the negative battery cable from the vehicle. Refer to *Battery Negative Cable Replacement* or *Battery Positive and Negative Cable Replacement* in SI.
5. Install a new negative battery cable. Refer to *Battery Negative Cable Replacement* or *Battery Positive and Negative Cable Replacement* in SI.
