# **Recall Bulletin**

### **PRODUCT SAFETY RECALL**

SUBJECT: Passenger Airbag Inflator Weld May Fracture Upon Airbag Deployment

MODELS: 2014 Chevrolet Silverado Crew Cab 2014 GMC Sierra Crew Cab

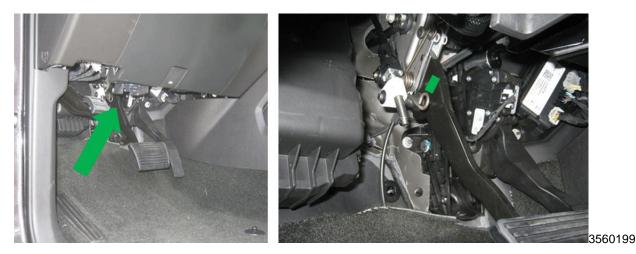
Determine if the instrument panel airbag has been replaced.

- If there is green <u>paint stripe or green dot</u> on the upper brake pedal arm, do NOT replace the instrument panel airbag. No further action is required.
- If a green paint stripe or green dot on the upper brake pedal arm is NOT present, replace the instrument panel airbag. Refer to the service procedure in this bulletin.

- 1. Remove the instrument panel airbag. Refer to Instrument Panel Airbag Replacement in SI.
- 2. Install a new instrument panel airbag. Refer to Instrument Panel Airbag Replacement in SI.
