Service Bulletin

SUBJECT: Service Update for Inventory and Customer Vehicles
4-Wheel Drive Transfer Case Adapter Housing
Expires with Base Warranty

MODELS: 2013 Chevrolet Silverado HD
2013 GMC Sierra HD
Equipped with 4WD and 6-Speed Automatic Transmission (MW7)

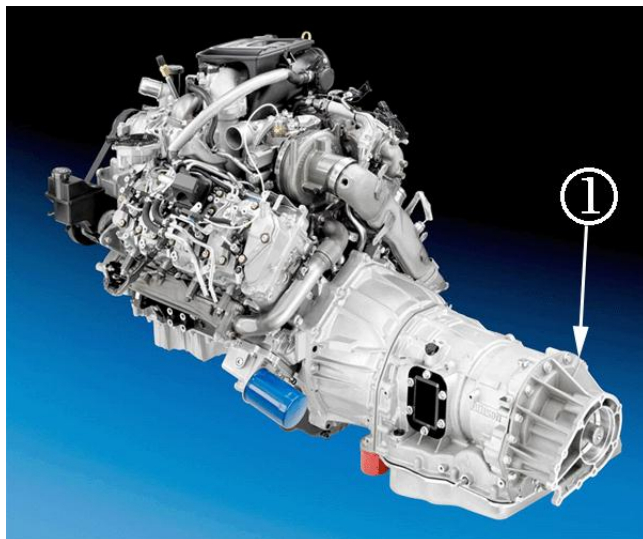
3638070

2. Locate the traceability number on the transmission low reverse clutch housing (1). The traceability number was written with a black paint marker.

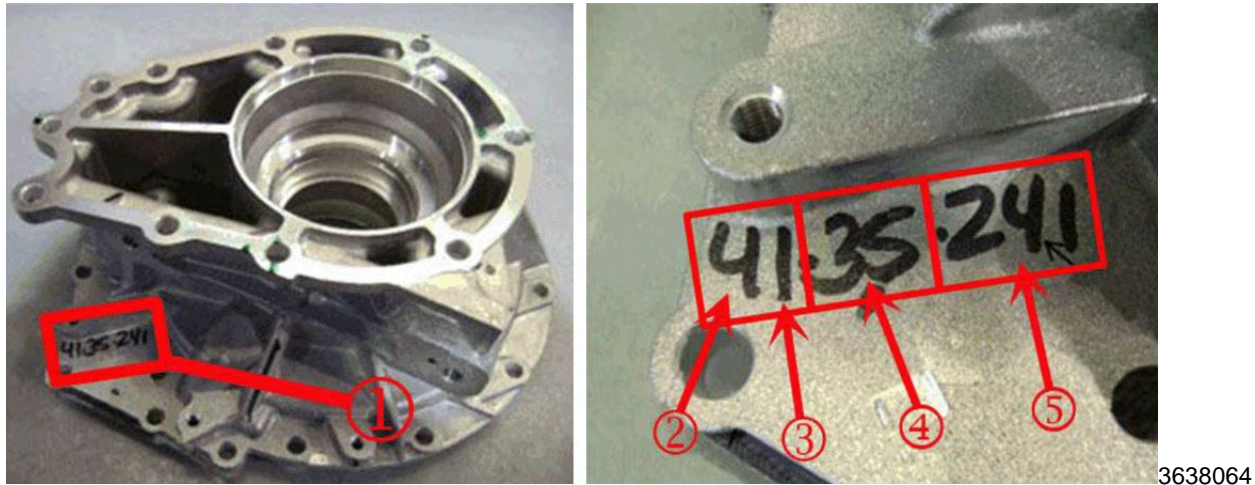
Numbers shown in the photograph above do NOT fall under the suspect parts. (1) Location of Traceability Numbers. (2) Machine Number (3) Fixture Number (4) Shift Sequence Number (5) Machine Julian Date.

3. Determine the traceability number written on the low reverse clutch housing. The number includes a machine number, fixture number, shift sequence number and machine Julian date. Refer to the photograph to review the breakdown of the traceability number.

- If the traceability number includes a machine and fixture number of black 31 or 32 and machine Julian date of 254, proceed to step 4.
 - If the traceability number includes machine and fixture numbers other than black 31 or 32 or a Julian date other than 254, no further action is required. Lower the vehicle. Refer to *Lifting and Jacking the Vehicle* in SI.

- If the test drive produces these symptoms, replace the 4WD extension housing. Proceed to step 5.
 - If the test drive does NOT produce these symptoms, no further action is required. Lower the vehicle. Refer to *Lifting and Jacking the Vehicle* in SI.

5. Remove low reverse clutch housing. Refer to *Low and Reverse Clutch Piston and Output Carrier Assembly Removal* in SI.
 6. Install new low reverse clutch housing. Refer to *Low and Reverse Clutch Piston Housing Installation* in SI.
