Service Bulletin

SUBJECT: Service Update for Inventory and Customer Vehicles
Rear Seat Entertainment DVD/CD Playback Mode Memory Loss
Expires with Base Warranty

MODELS: 2013 Cadillac SRX
Equipped with Rear Seat Entertainment Package (UWG)

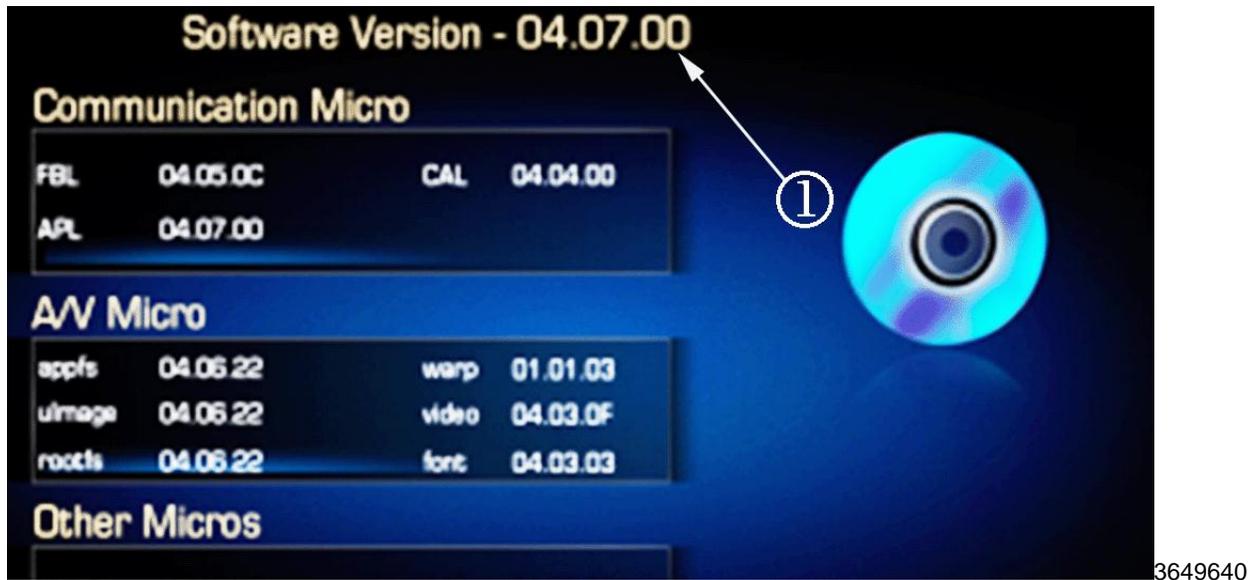
1.5 Determine software version. Refer to photograph to determine the location of the software version (1) on the display screen.

- If the software version is **04.07.00**, a software update is required. Refer to *SPS and USB Programming* in this bulletin.
- If the software version is NOT 04.07.00, no further action is required.
