Service Bulletin

Bulletin No.: PIC5267B

Subject: Various Noises From Sunroof Area

Models: 2008 - 2013 Cadillac CTS
2010 - 2013 Cadillac CTS Wagon

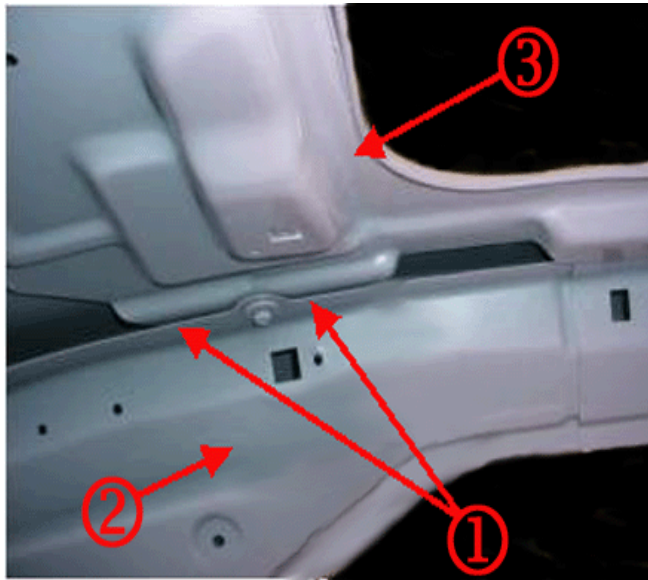
2176007

A customer may comment about a rattle, tapping, or creaking from the rear area of the roof while driving. The cause may be intermittent contact between the body side panel and the sunroof reinforcement panel in the rear corner of the roof. (Does not include CTS Wagon)

Lower the headliner in the corner where the noise is coming from to confirm the source. Applying pressure with your hand to the panels in this area can lessen or eliminate the noise. The cause may be intermittent contact (1) between the body side panel (2) and the sunroof reinforcement panel (3) in the rear corner of the roof.

There is a structural adhesive between these panels. If noise is coming from this area use a screw driver or chisel to create a small amount of separation between the panels in the area of contact (1).

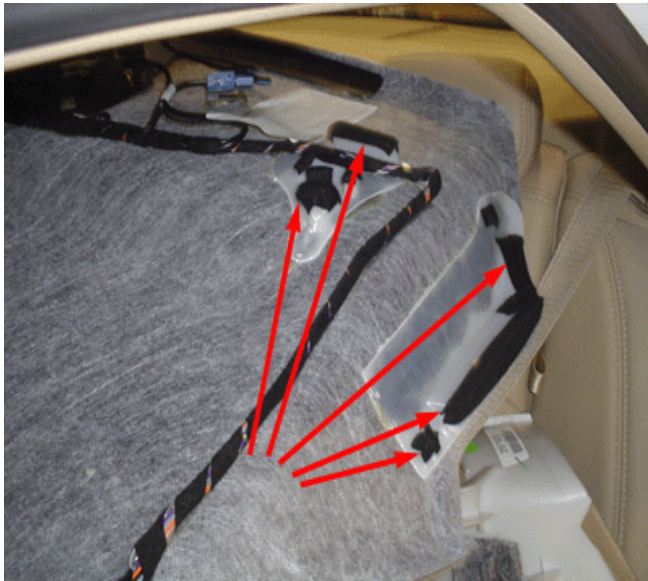
2354361

A customer may comment of a tick noise coming from the roof area while going over a rough road. The cause may be the energy absorbing safety plastic material that's on the back of the headliner contacting the roof metal.

Add pieces of felt to the top of the safety plastic material to isolate it from the roof.

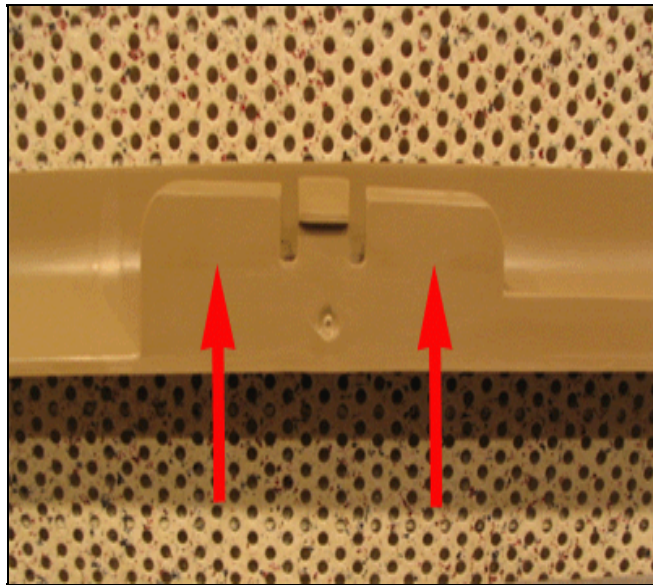
2354364

A customer may comment about a creak noise coming from the sunroof area. The cause may be the sunroof trim ring contacting the sunroof.

Pull the sunroof trim ring out of the vehicle and verify the noise is gone. If so add Mylar or Ultra high molecular weight tape (clear, robust tape) to the top surface of the attachments to isolate the trim ring from the sunroof metal.

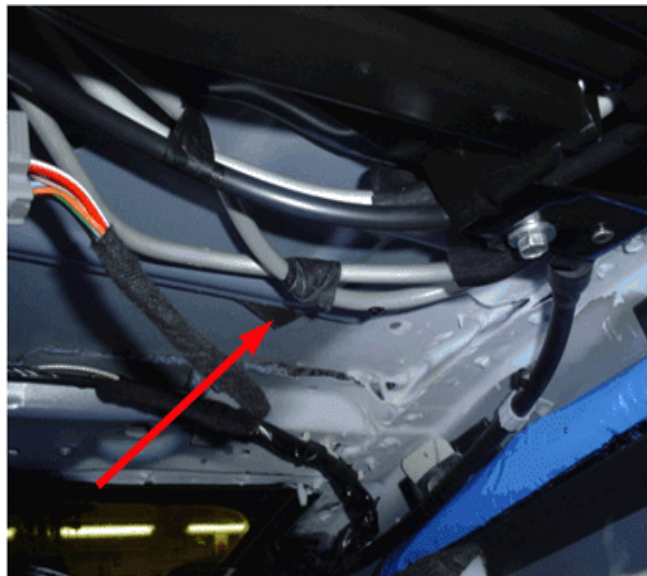
2371292

Another area of a tick or rattle noise coming from the roof could be the sunroof reinforcement metal contacting the roof sheet metal.

To isolate the tick or rattle noise, place a piece of hard foam between the sunroof reinforcement metal and the roof sheet metal. Each foam piece should be approximately 4"x4" in size and about 5mm thick.

Note: Be careful not to distort the roof sheet metal when adding the piece of foam.
