Service Bulletin

Bulletin No.: PIC5515C

Subject: Diagnostic Tip - Ratchet Click or Grind Noise In Front Of Vehicle Traveling Straight At Slow Speeds

Models: 2010 - 2014 Chevrolet Camaro

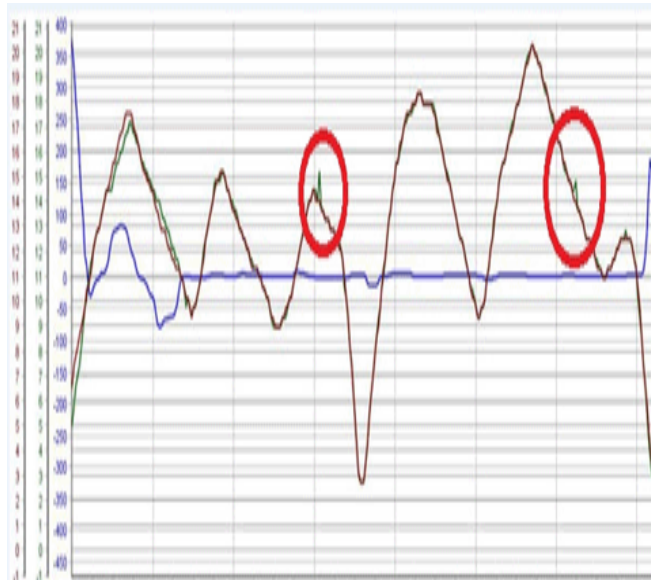
2874501

In the example above, the vehicle is travelling straight (Steering Column Position in Blue); the Left Rear WSS (Green) is spiking; while the Right Rear WSS (red) is not.

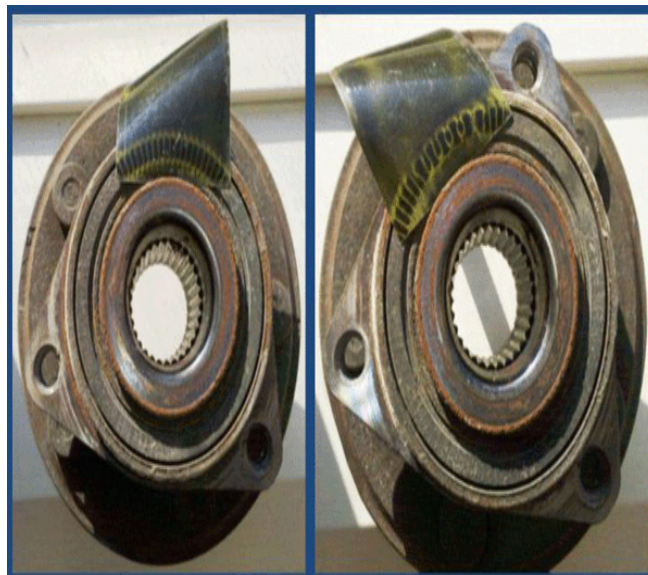
2870569

Note: This photo depicts a condition of the encoder magnetic poles not alternating properly. Instead of the magnets being laid North, South, North, South, as the photo on the left illustrates, the poles may have been laid out of sequence as illustrated by the photo on the right. The magnetic paper is not readily available in most areas so this photo is only being used to illustrate that not all conditions are visible to the naked eye and that if this condition were present then swapping the WSS would not aid in isolating this cause. It may be necessary, as explained below, to swap the hub bearing from side to side to identify the condition shown in this photo.

* If there is no evidence of physical damage, contamination or debris it is acceptable to swap the hub bearings from side to side, test drive the vehicle again and confirm the problem followed the hub. If the problem follows the hub, replace the hub. If problem stays with the WSS, replace the WSS.
