Service Bulletin

Bulletin No.: PIT5209

Subject: Unwanted Alarm Sounding (GM Accessory Inclination Sensor Mounting)

Models: 2007-2013 Cadillac Escalade Models
2007-2013 Chevrolet Avalanche, Silverado, Suburban, Tahoe
2007-2013 GMC Sierra, Yukon Models

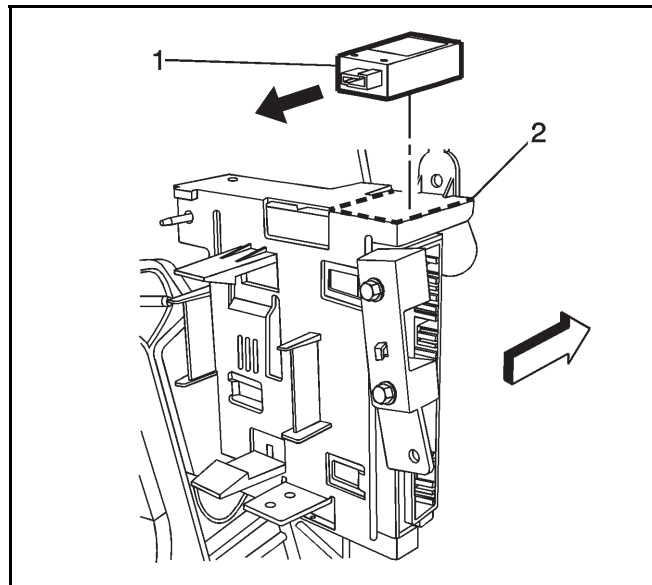
2850628

Some owners may comment that for no reason the alarm will go active. This would normally occur after the vehicle has been sitting awhile following a drive cycle. The sensor was originally positioned on the driver's side lower HVAC duct. With thermal cycling the duct could expand and contract enough that, depending on exact sensor location, movement of the duct might cause the sensor to trip and activate the alarm.

The location of the sensor placement has been updated to the top of the BCM bracket. See picture below. Relocate the sensor to the top of the BCM bracket as shown in the attached:
