Service Bulletin

Bulletin No.: PIT5030E

Subject: Diagnostic Tip - Intermittent No Crank When Ignition Key Is Turned To The Crank Position

Models: 2010 - 2014 Buick LaCrosse, Regal
2012 – 2014 Buick Verano (Without RPO BAH Or ATH)
2013 – 2014 Buick Encore
2013 – 2014 Chevrolet Trax (Canada only)
2010 - 2014 Chevrolet Camaro, Equinox
2011 - 2014 Chevrolet Cruze
2012 - 2014 Chevrolet Sonic
2010 - 2014 GMC Terrain

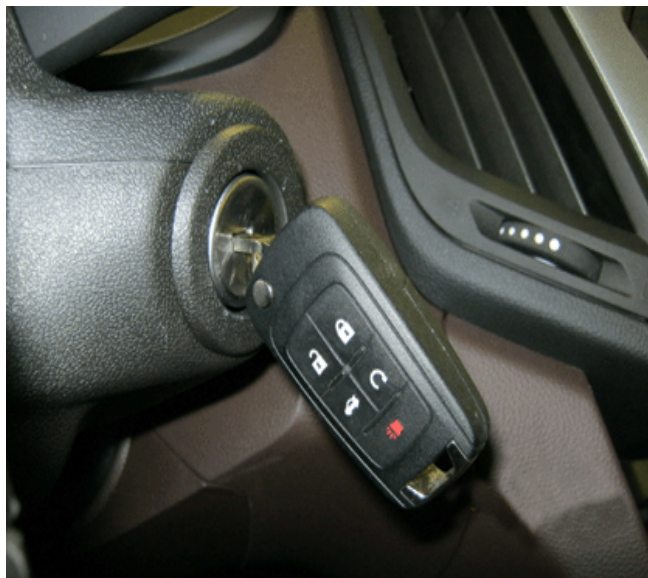
Customers may comment on an intermittent no crank. The design of the key and fob is to have the key extended straight out. If the key is not in the fully locked position and the head of the key is angled down, the vehicle may not crank. This may be caused by the customer contacting the release button on the fob when inserting the key into the ignition.

Incorrect

If the vehicle will not crank, remove the key and make sure it is fully extended. Reinsert the ignition key in the extended straight out position and turn to crank engine. Reference photos below.

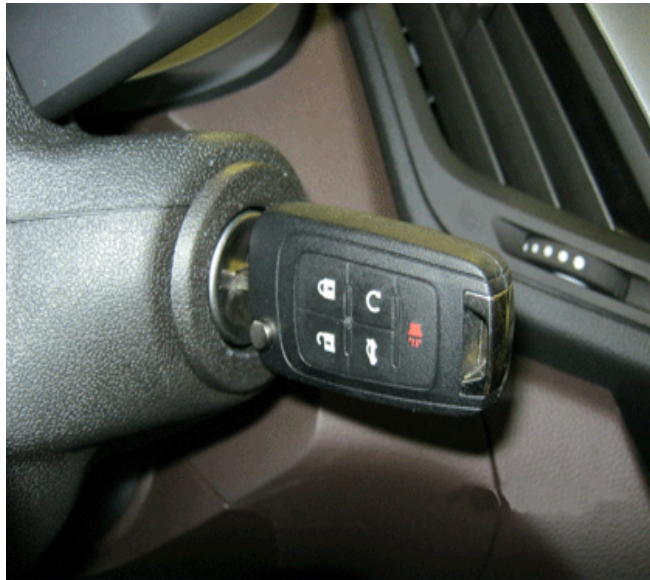
Correct

Please share this information with the customer. Please be sure to fully extend and lock the ignition key PRIOR to inserting the key into the ignition switch and attempting to start the vehicle - as reflected in the photos above.
