# Service Bulletin

Bulletin No.: PIT5072D

**Subject:** Power Liftgate Does Not Stay Fully Open Or Drifts Down A Few Inches

**Models:** 2010 - 2013 Chevrolet Equinox  
2010 - 2013 GMC Terrain

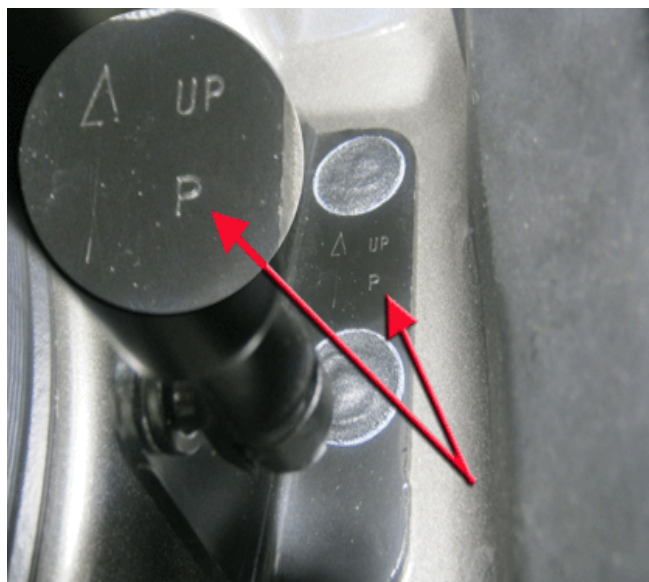
2598278

This may be caused by the incorrect strut mounting brackets installed on the vehicle. Check on the liftgate mounting brackets for a letter P or M stamped on the bracket. P is for a power liftgate system and M is for a Manual liftgate system. If Manual strut mount brackets are found on the vehicle, replace with the correct bracket(s) for power liftgate.

The picture above is an example of the correct brackets for a power liftgate.
