Service Bulletin

Bulletin No.: PIT5191A

Subject: Intermittent Dead Battery Or Intermittent Shift To Park Message Displayed On DIC

Models: 2013 Cadillac SRX

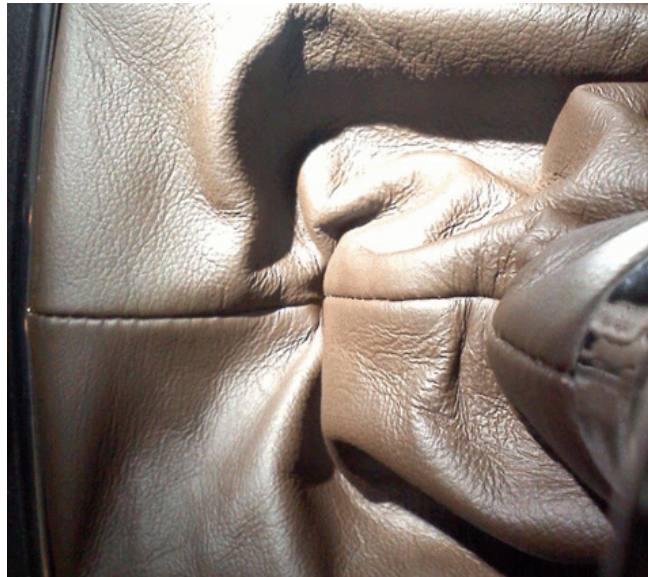
3226372

The shifter boot may become pinched between the shifter housing and the shifter lever.

If this should happen, the transmission will mechanically be in Park and the vehicle will not move, however the micro switch that sends the park input to the cluster may send an invalid signal which will cause the vehicle ignition to stay in the Run state therefore causing a battery drain condition.

Inspect the shifter boot for signs of being pinched. Review the picture below, which shows the pinched shifter boot condition.

If this condition is found, replace the shifter boot using the part number listed in the electronic parts catalog.
