Technical Service Bulletin

40 Front stabilizer bar is noisy

40 13 31 2010330/4 July 19, 2013. Supersedes Technical Service Bulletin Group 40 number 08-11 dated November 14, 2008 for reasons listed below.

Model(s)	Year	VIN Range	Vehicle-Specific Equipment
TT	2004	000001 - 025177	Not Applicable

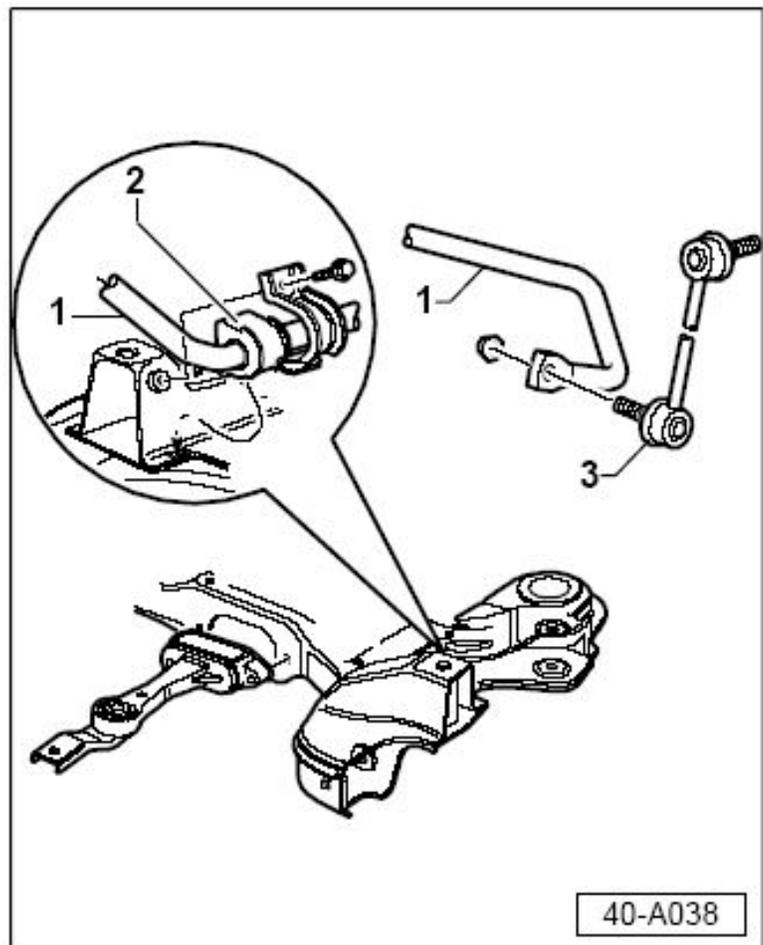
The noise may be caused by the bushing sleeve separating from the stabilizer bar. The noise is generated when the bar moves up and down.

1. Test drive the vehicle to verify customer concern. The noise may only be present when vehicle is either warm or cold.
2. Visually inspect underbody for damage.
3. Inspect the front stabilizer bar (Figure 1, 1) at rubber mount (Figure 1, 2) for any signs of damage, such as the bushing sleeve separated from stabilizer bar.

Figure 1. Front stabilizer bar (1), rubber mount (2) and coupling links (3).

1. Disconnect left and right side coupling links (Figure 1, 3) from front stabilizer bar and move stabilizer bar (Figure 1, 1) up and down several times. Observe rubber mount (Figure 1, 2) for any signs of damage, such as the bushing separated from stabilizer bar.
2. If bushing has separated from stabilizer bar, replace stabilizer bar. (Only new version parts are available as replacement parts).
