Technical Service Bulletin

40 Rattling/knocking noise from front end over bumps

40 13 37 2035854/1 December 3, 2013.

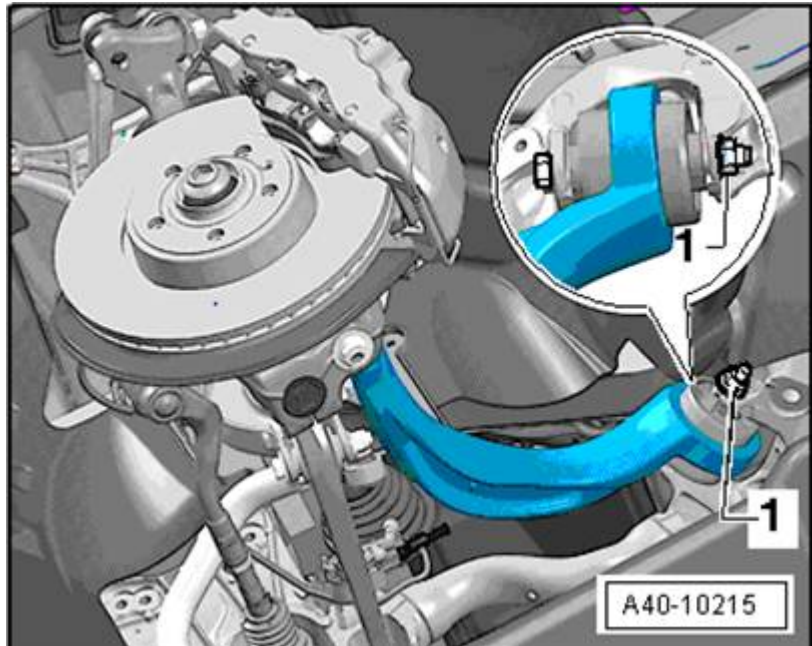
Figure 1. Lower guide link

- The customer reports hearing a rattling or knocking noise when the car is driven over bumps or uneven road surfaces. The noise is noticed after the car has been driven for a while and is warmed-up, and when the temperature outside is warm.
- The condition can be duplicated if the brakes are applied while the car is driven over bumps.

High ambient temperatures at the hydraulic guide links cause the noise.

1. Confirm that the noise is coming from the guide link(s) and not from other suspension components on the vehicle (e.g., worn or damaged bushings or suspension components).
2. After the noise is confirmed to be from the guide links, replace both left and right lower guide links (Figure 1) according to the instructions in *Elsa >> Repair Manual >> Chassis >> Suspension, Wheel, Steering >> Front Suspension >> Removal and Installation >> Guide Link*.
