Technical Service Bulletin

43 Air suspension height is uneven, pressure holding valve closed

43 13 13 2020095/5 March 4, 2013. Supersedes Technical Service Bulletin Group 43 number 13-12 dated February 4, 2013 for reasons listed below.

Model(s)	Year	VIN Range	Vehicle-Specific Equipment
Q7	2007 - 2010	000001 - 999999	Not applicable

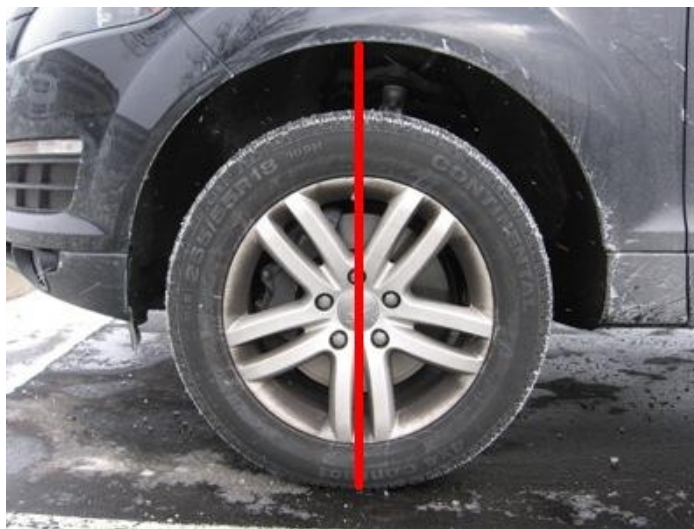
Figure 1. The distance to be measured.

1. Check the tire pressures. If necessary, adjust to the proper pressures. This is important to ensure accurate measurements.
2. Park the vehicle on a level surface. Leave the engine running to ensure full battery voltage for testing.
3. Using the MMI system, raise the suspension to a lifted level. At each wheel location, measure and record the height at the edge of the fender well (Figure 1).
