Bulletin No.: PIE0275

Service Bulletin

Subject: Engineering Information – Low Coolant Level, Coolant Leak, Coolant Odor, Heater not Working Properly, Engine Overheating

Models: 2013 Chevrolet Cruze, Sonic
Equipped with 1.4L Turbo Engine (RPO LUV)
Vehicles Sold in United States Only

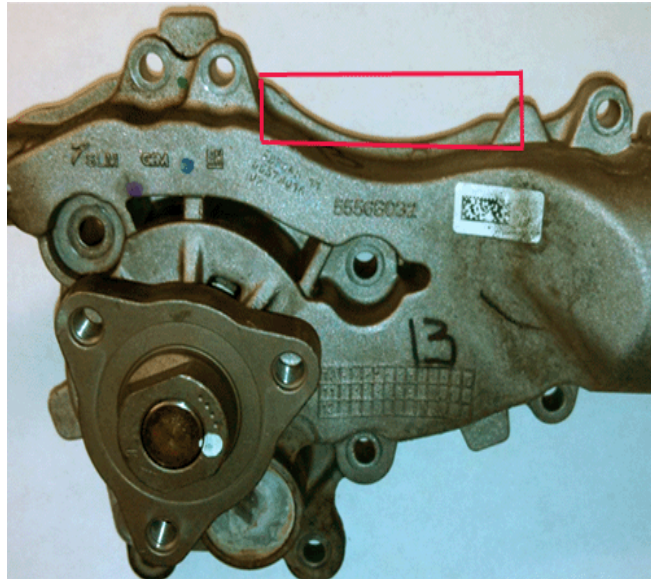
3661085

This condition may be caused by a leaking water pump gasket. This gasket is located between the water pump housing and the engine front cover.

1. Inspect for evidence of coolant leaking along the upper section of the water pump casting (area in red). This section of the pump casting is curved and located above the pump shaft center line and in between the water pump pulley and thermostat.

If one or both of these leaks are detected, contact the engineer listed below for further instructions. DO NOT disassemble any components prior to making the call to engineering. Engineering may request the parts being replaced for inspection.

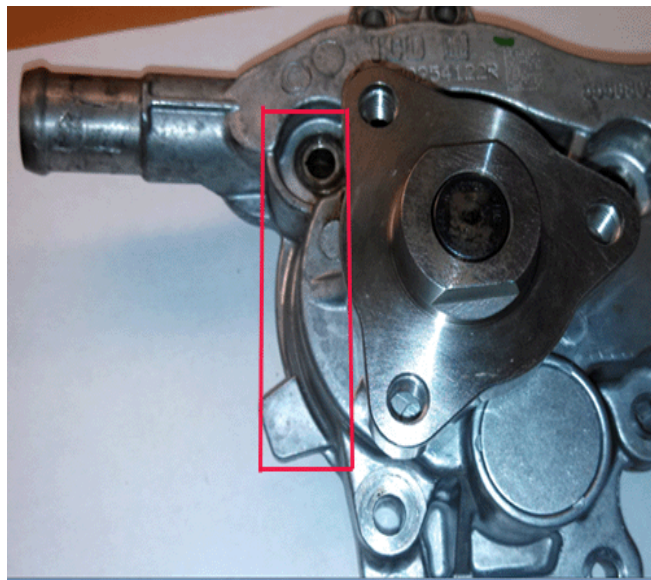
3661087

2. Also inspect for traces of coolant along the pump casting located between the outlet to heater core and water pump shaft (area in red). This leak is coming from the mounting bolt hole. The mounting bolt hole is located above the center line of the pump shaft, behind the water pump pulley and in between the outlet to heater core and water pump shaft.
