# Technical Bulletin

Model(s)	Year	Eng. Code	Trans. Code	VIN Range From	VIN Range To
Routan	2012	All	All	All	All

91 13 21 September 17, 2013 2033285

### RHR Navigation Map Enhancements

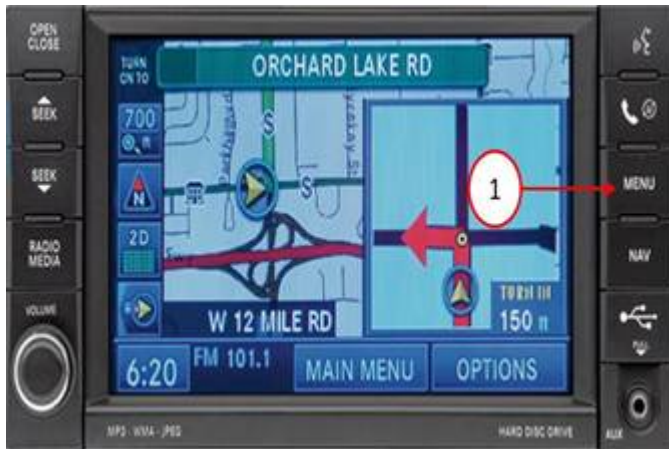
Figure 1

1 - MENU Key

1. Switch ignition to the RUN position
2. Switch the Radio ON.
3. Press the MENU key (Fig. 1).

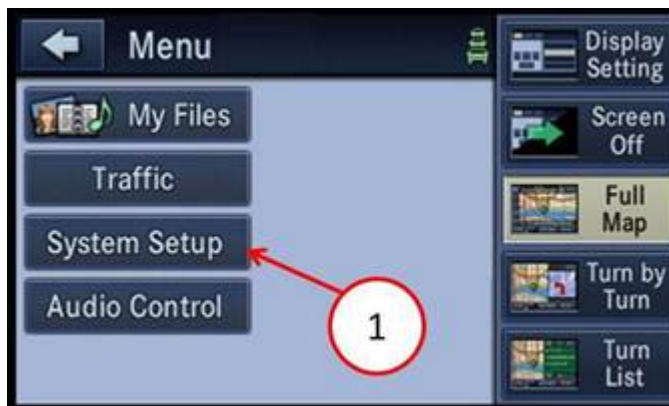
Figure 2

1 - System Setup

4. Press System Setup (Fig. 2).

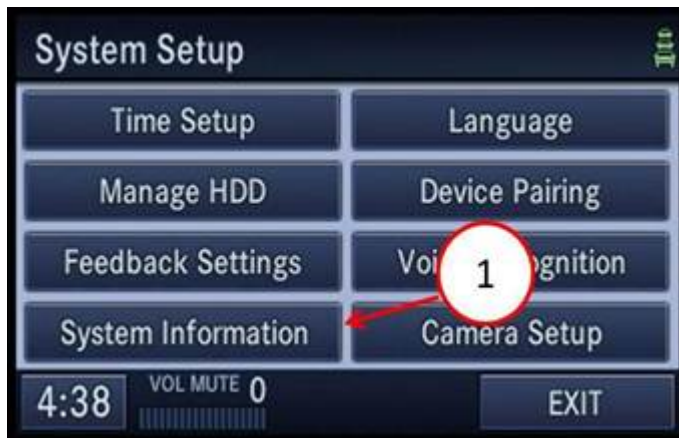
Figure 3

1 - System Information

5. Press system information (Fig 3)

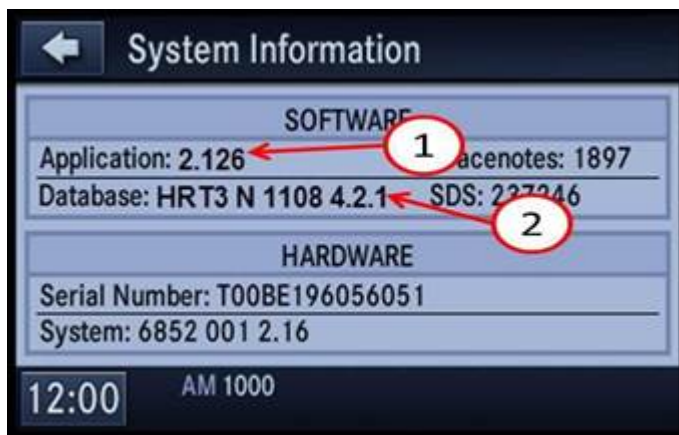
Figure 4 Software versions

1 - Application Software

2 - Database Software Version

6. Is the application software level at 2.126? (Fig. 4)

a. No >>> Perform technical bulletin 2031926 Software Enhancements for Radio Model RHR (91-13-02) first, before proceeding with this bulletin.

b. Yes >>> proceed to Step #7.

7. Is the Database software level at 4.3.1 or higher? (Fig. 4).

a. Yes >>> This service bulletin doesn't apply, normal diagnostic should be performed.

b. No >>> Proceed to Step #8.

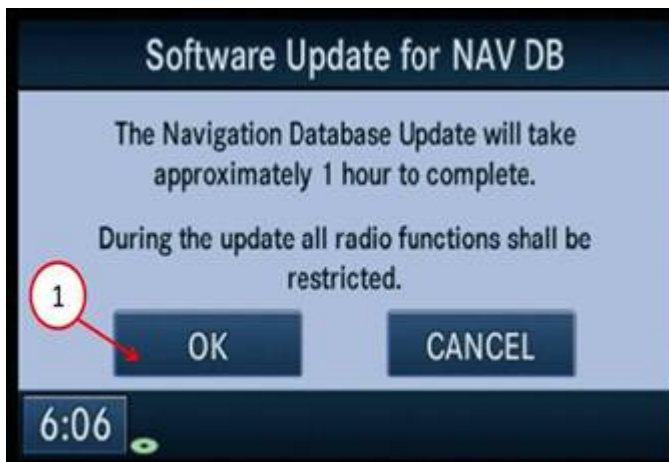
Figure 5.

1 - Press OK

10. The radio will read the contents of disc and will prompt the user to select "OK" or "CANCEL" as shown in the screen below. It may take approximately 2 minutes for this prompt to display (Fig. 5).

11. Press "OK"(Fig. 5).

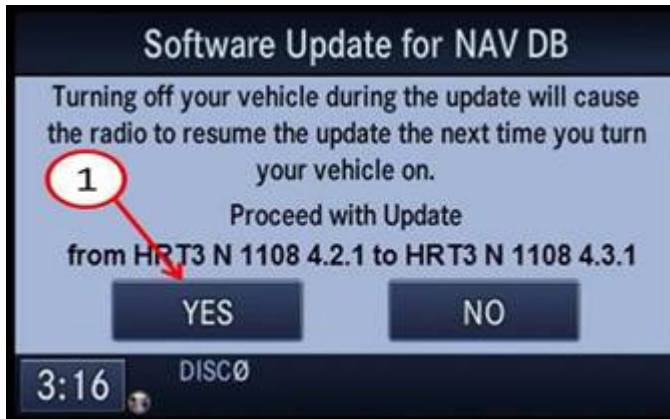
Figure 6 Current and Update Software Level

1 - To Proceed Select "YES"

12. The next screen will display the current and new version of the Navigation Map database software.

13. Press YES to continue. (Fig. 6).

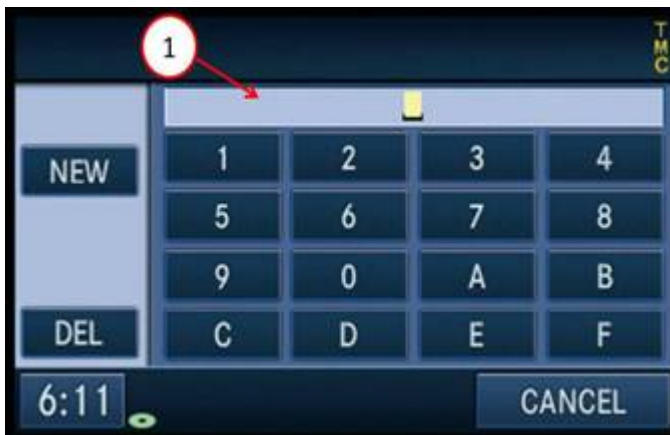
Figure 7

1 – Activation Key

14. When prompted by the radio enter the activation key obtained in Step #8.

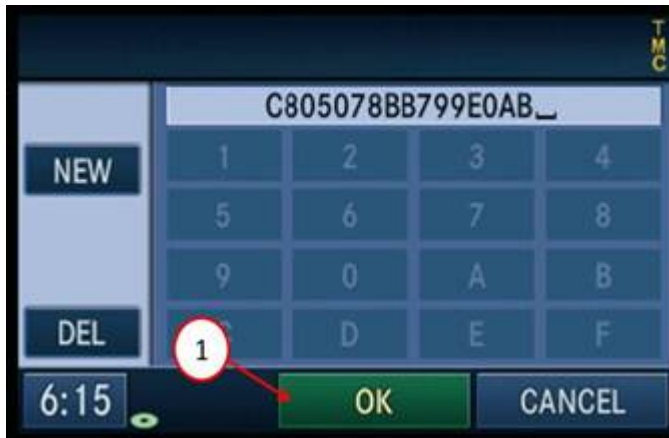
Figure 8.

1 - Press OK

15. After successful entry of the activation key, the following screen will be displayed (Fig.8)

16. Press "OK" and the update process will begin.

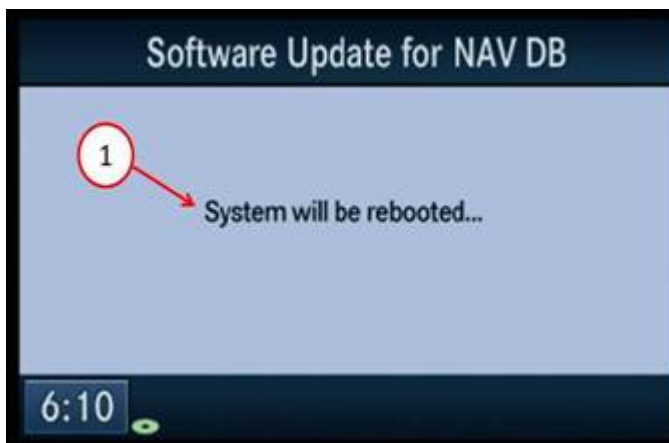
Figure 9.

1 - System Reboot

17. The following screen will be displayed (Fig 9)

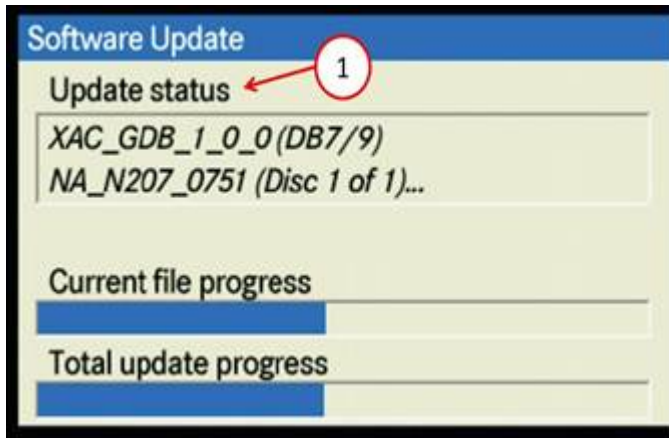
Figure 10

1 - Status

18. After the radio resets, the following screen will be displayed (Fig. 10)

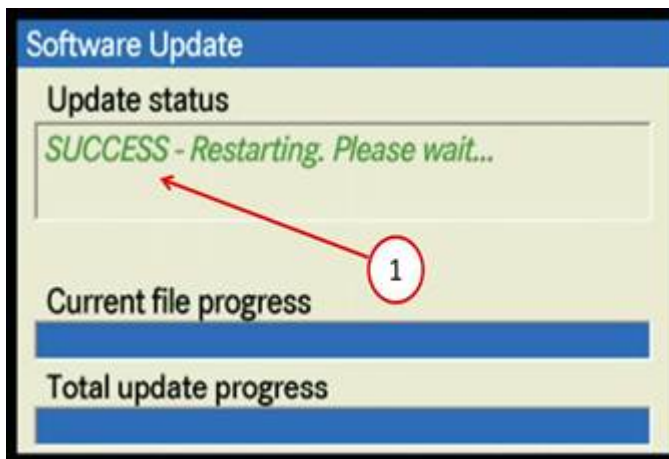
Figure 11

1 - Success

19. After successful update, the following screen will be displayed (Fig. 11)
