Service Bulletin

Bulletin No.: PIP5123B

Subject: SES Lamp On With DTC P2270

Models: 2013 Chevrolet Silverado
2013 GMC Sierra
Built with 4.8L 5.3L 6.0L RPO L20 LC9 LMG L96

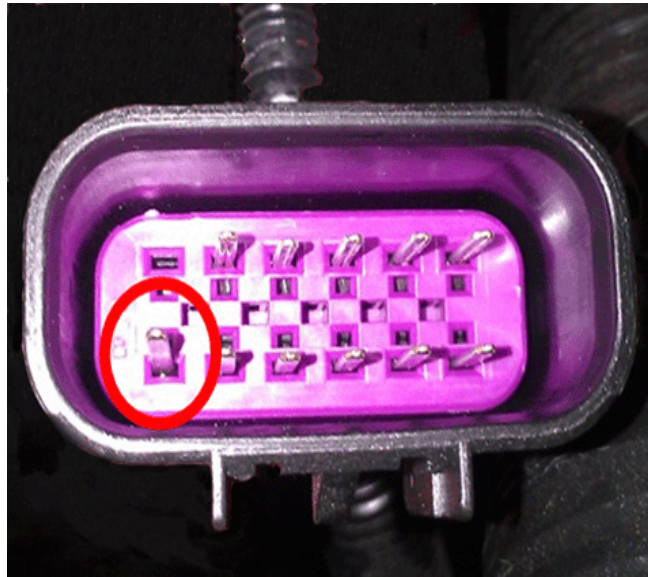
3454867

Concern of DTC P2270 setting along with any of the following codes P0140, P0139, P0138, P0137, P013A, P013B on vehicles built at the Fort Wayne and/or Silao assembly plants during January or February of 2013.

Check connector X131 for a bent terminal F as indicated in the attached PIC and repair per SI procedures.
