Service Bulletin

Bulletin No.: PIP5131

Subject: SPARK EV (BEV) 1ET35 Drive Unit Exchange Program

Models: 2014 Chevrolet Spark EV (BEV)
Equipped with 1ET35 Transaxle (RPO MME)

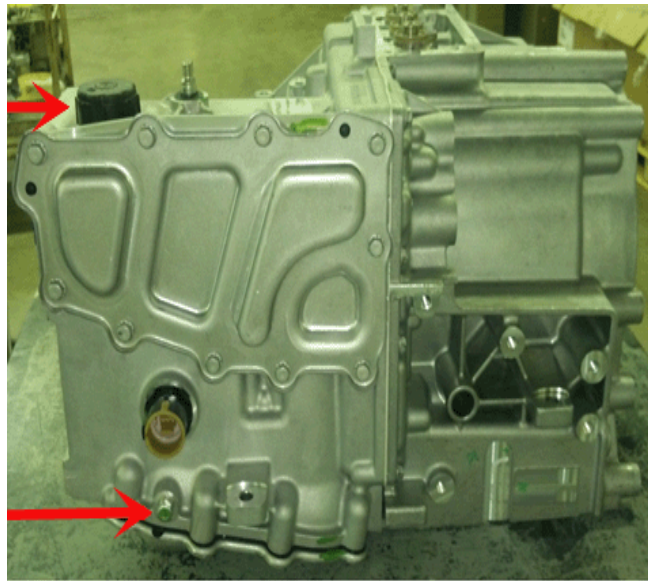
3471382

The 1ET35 Drive Unit is not equipped with a fill tube or dipstick.

Therefore, a fill cap in the top of the Drive Unit (see top arrow) and level set plug (see lower arrow) sets the fluid level. 0

1. Operate vehicle until Drive Unit fluid temperature is 30–50°C (86–122°F).
2. Raise the vehicle.
3. Remove the front compartment air deflector.
4. Place the Drive Unit in Park.
5. With the scan tool, command the auxiliary Drive Unit Fluid Pump speed to ON for 10 minutes.
6. Remove the Drive Unit case level set plug.
7. Verify fluid slowly drips from the hole that the case level set plug was removed from.
 - a. If the fluid is flowing as a steady stream, wait until the fluid begins to drip from the case level set plug hole.
 - b. If no fluid comes out, add .5 L (.52 Qts.) of fluid until fluid drips out of the case level set plug hole.
8. Install Drive Unit case level set plug and torque to 12 Y (106 lb. in).
9. Turn off the vehicle.
10. Install the front compartment air deflector.
